## Cardinal Home Inspections

# HOME INSPECTION REPORT

# PROPERTY INSPECTION REPORT FORM

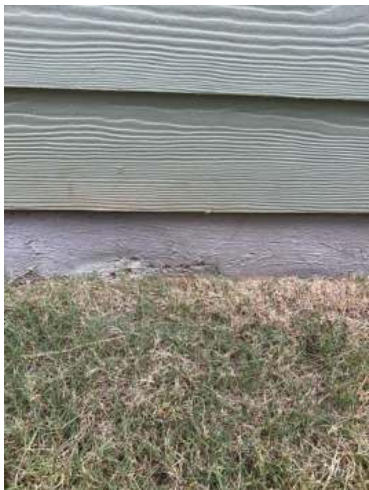
Right Side Yard

1: Slab Perimeter: Parged in Areas

The slab appeared to have had a parge coating added over it at the referenced area(s) after original construction. I recommend consulting with the seller(s) and/or builder to try and determine why. If no information can be found, evaluation is recommended to be conducted by a qualified concrete contractor.

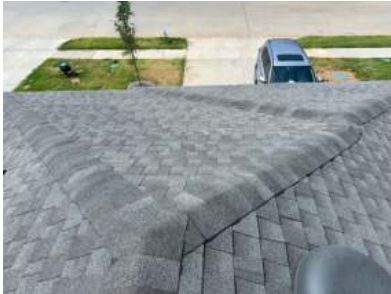
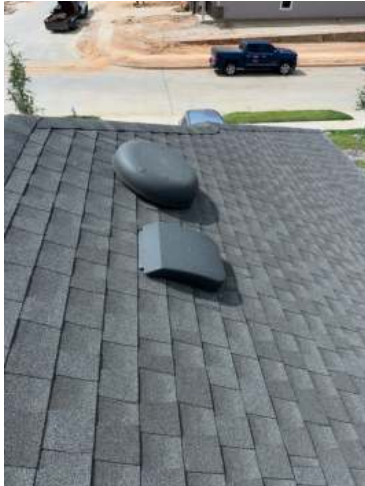
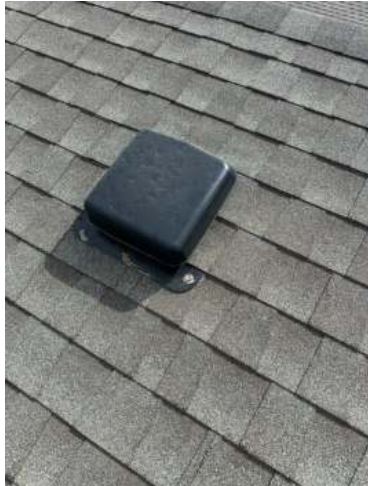
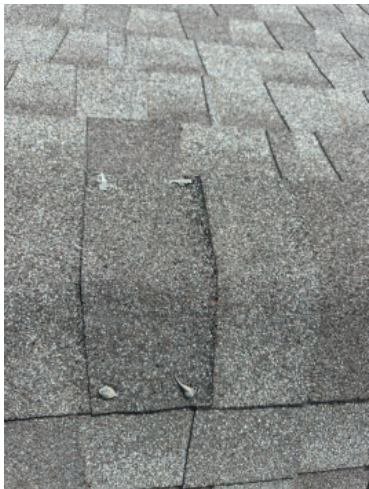
1: Boot Flashing(s): Improper Shingle Coverage

There were boot flashings(s) present that had shingles improperly installed and/or not present. The uppermost 1/2 of the flashing flange should be covered by shingles. This can potentially allow for leaks around the boot if the boot and/or shingles are not properly installed. Recommend a qualified roofing professional further evaluate all areas where shingles are improperly installed and/or not present over the boot flashings and repair/replace as needed.

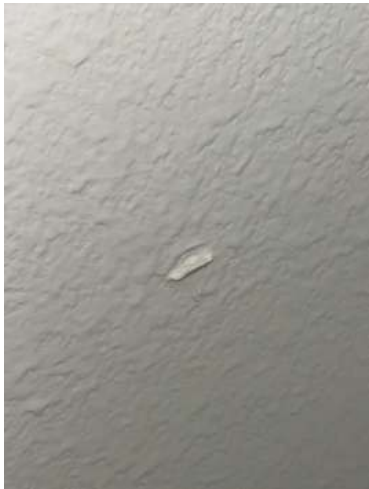
Front Entry closet

5: Drywall: Damage

Drywall damage was present in areas. Repairs are recommended to be performed as needed by a drywall contractor or other qualified person.

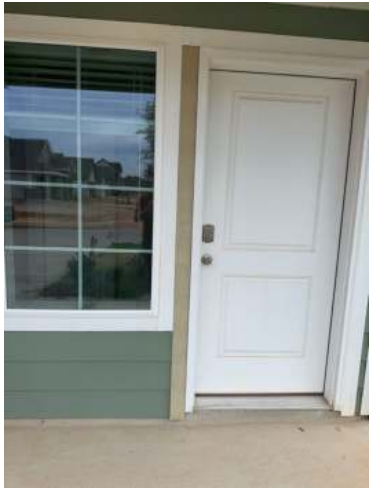
Front Entry Main Entry

6: Exterior Wall(s): Sealant Missing/Deteriorated

There was sealant present that was in need of maintenance/re-application at the referenced area(s). Properly sealing these areas is recommended to be performed by a qualified person to prevent moisture infiltration.

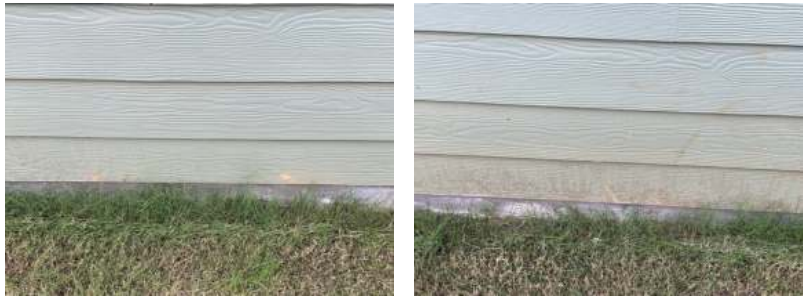
Right Side Yard

7: Fiber Cement: Damage (Minor to Moderate)

Sections of the fiber cement siding had minor to moderate damage. Repairs or replacement of these sections is recommend to be performed by a qualified contractor.

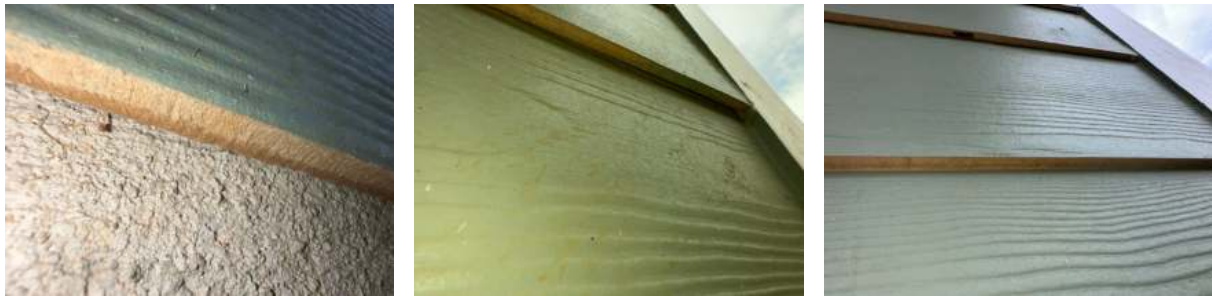
Exterior Walls

During the exterior inspection, the lower portion of the **cladding and trim** on the walls was found to be **unpainted**. Without a protective paint coating, these wood or composite surfaces are exposed to moisture, which can infiltrate joints and cause the material to swell, warp, or rot over time.

The lack of paint also reduces the barrier against UV radiation and seasonal temperature changes, potentially accelerating surface degradation and leading to future maintenance issues.

Standard industry practice calls for continuous paint coverage on exterior wood components to maintain the building envelope integrity. Gaps in coverage can become points of water entry, especially in regions with high precipitation or humidity, and may lead to hidden rot that is not immediately visible.

It is recommended that the affected areas be prepared and painted with an appropriate exterior-grade coating to protect the surfaces, prevent moisture intrusion, and extend the service life of the cladding and trim.

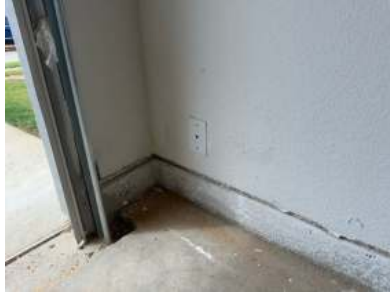
Garage

During the inspection, **drywall paint** adjacent to the **garage door opening** was observed to be **peeling**. The condition indicates loss of adhesion and potential exposure of the underlying substrate.

This type of deterioration can progress if moisture infiltrates the wall cavity, potentially leading to mold growth or structural concerns.

Recommendation: Repaint the affected area after proper surface preparation to prevent further deterioration.

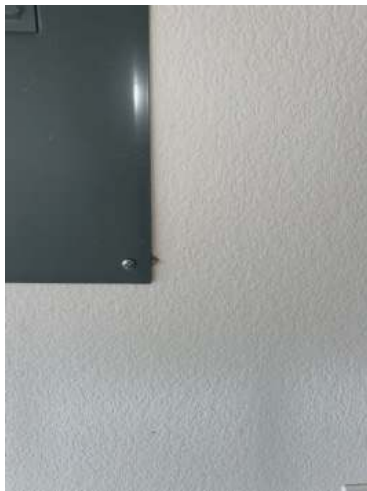
Garage

A **drywall gap** was observed behind the attached **dead front** of the electrical service panel. The opening is visible and measures a few centimeters, exposing the interior of the panel cavity to the surrounding wall cavity.

This condition may allow moisture or pests to enter the panel area and could affect the panel's integrity over time. It is recommended to have the gap sealed by a qualified professional to maintain proper fire-rating and protection.

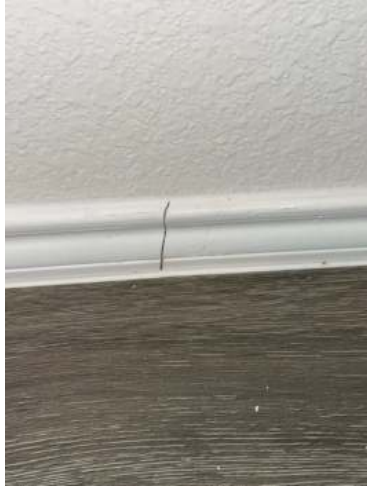
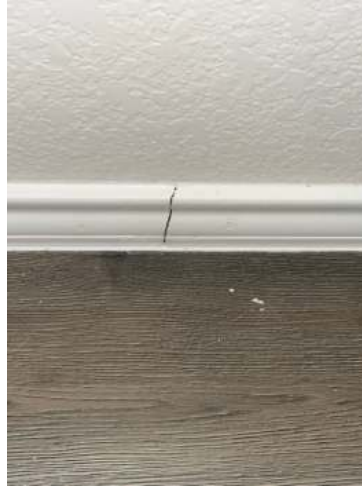
Living Room

3: Interior Trim - Incomplete Caulking Observed

During the interior inspection, the trim throughout the living area was observed to have sections where the caulking is missing or incomplete. **Uncaulked joints** can allow moisture intrusion and may lead to wood rot or draft issues over time. It is recommended to apply a continuous bead of appropriate exterior-grade caulk to all gaps to protect the trim and maintain the building envelope.

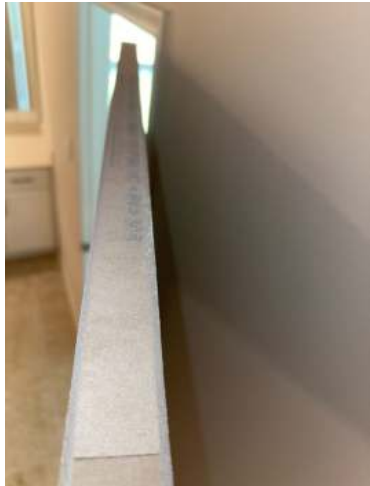
Primary Bedroom Primary Bathroom Bedroom 2  
Bedroom 3 Bedroom 4

6: Interior Doors: Tops and Bottoms Unfinished

Tops and bottoms of interior doors not painted. Manufacturers require all six sides to be painted for protection from humidity and warping, or warranty voided.

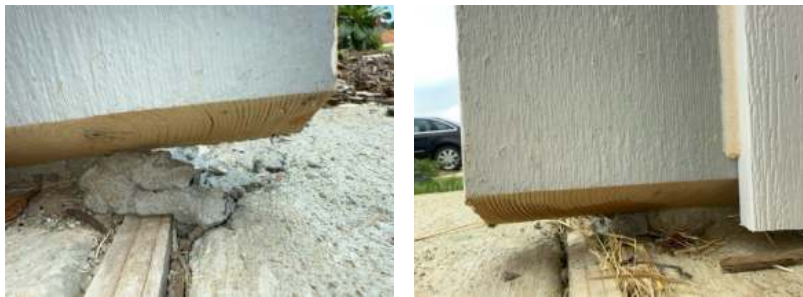
The **garage door trim** was observed to have a faded, uneven finish and areas where the paint has peeled, indicating that repainting is required.

Recommendation: Apply a fresh coat of appropriate exterior paint to protect the trim and restore its appearance.

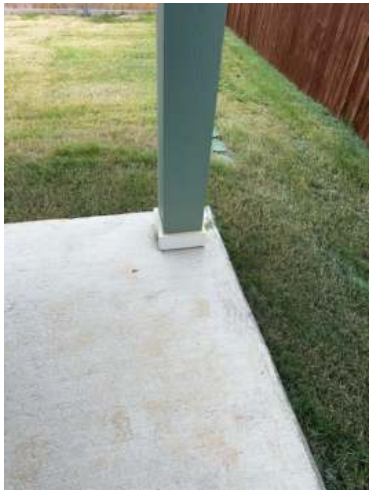
**1: Wood to Ground**

Decking supports and members in direct contact with ground. This is conducive for wood decay and/or insect intrusion.

**Recommendation:** Install a suitable moisture barrier or provide a physical separation (e.g., pressure-treated spacer) between the post and concrete to mitigate potential rot or decay. This condition can accelerate deterioration if left unaddressed.

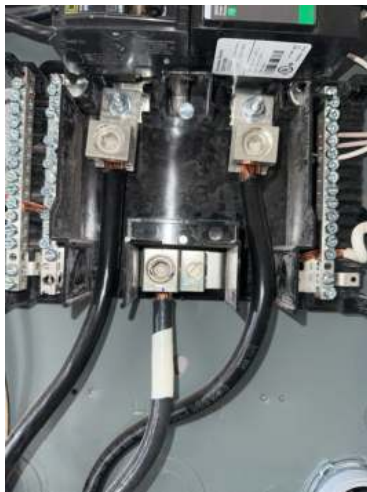
Garage

Missing main lug caps.

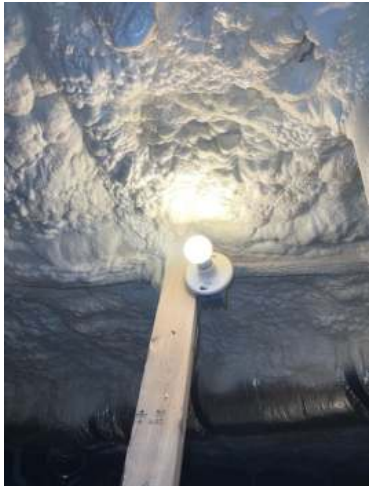
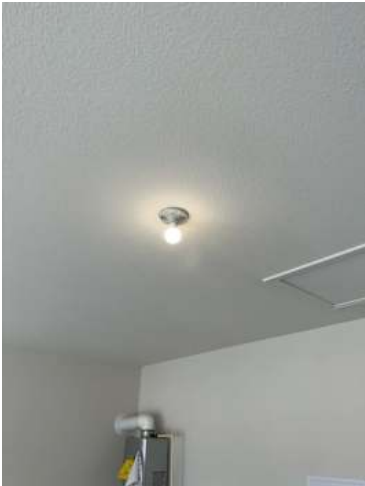
There were bare bulbs present on the referenced light fixture(s). The installation of covers or globes on any fixtures in the structure without globes is recommended to be performed by a qualified person to prevent accidental breakage, and possible related safety and shock hazards.

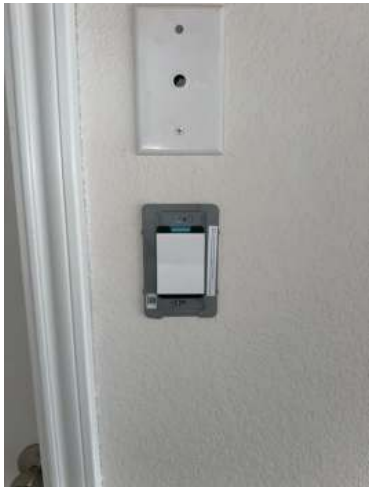
Garage

There were missing switch cover plate(s) present at the referenced area(s). This exposes live wiring and is a potential shock hazard. The installation of cover plates is recommended to be conducted on any switches missing plates by a qualified person.

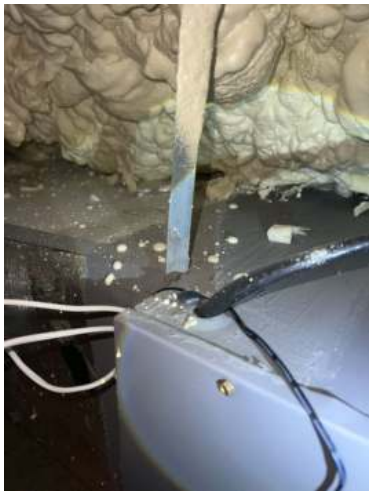
Attic

A romex connector / strain relief bushing was missing where the conductor powering the unit entered the enclosure. This connector secures the wire to the unit - preventing damage. Repairs are recommended to be conducted by a licensed electrician or HVAC contractor.

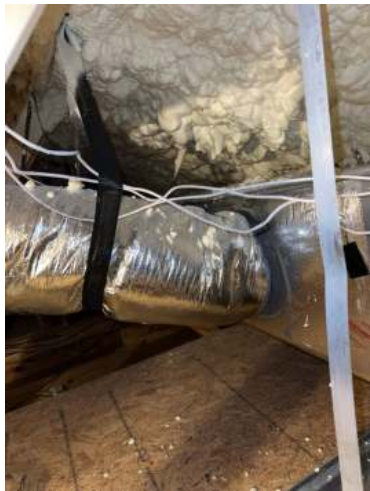
The inspector observed that the **conditioned attic** does not have any ventilation opening or vent installed. Absence of proper attic ventilation can lead to elevated temperatures and moisture accumulation, which may affect the performance and longevity of the HVAC system and insulation.

4 inch duct opening should be installed to allow the proper airflow into the attic space.  
Per HVAC 2021 IRV code 5.1.3 and 5.2.10.  
50 CFM per 1000 sq ft of ceiling.  
Attic

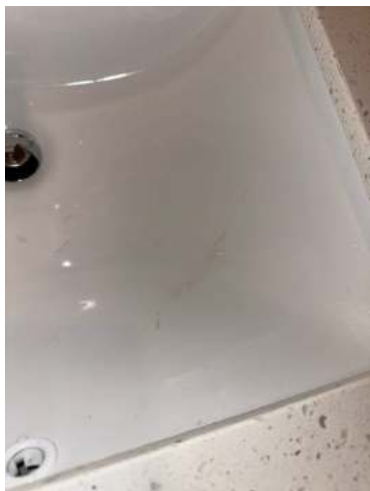
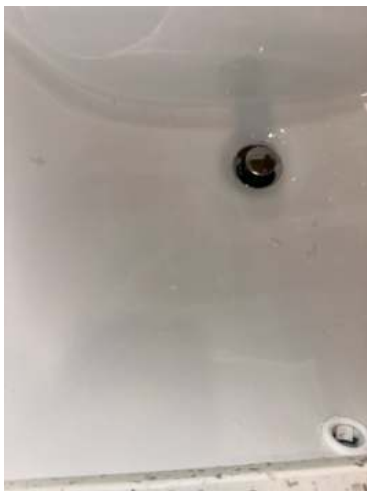
Primary Bathroom

During the inspection, **caulk was observed inside the basin of the bathroom sink** in the primary bathroom. The presence of caulk can trap moisture and promote mold growth if not addressed. It is recommended to remove the excess caulk and reapply a fresh, properly sealed bead to maintain a watertight seal and prevent potential water damage.
