## Cardinal Home Inspections

## HOME INSPECTION REPORT

# PROPERTY INSPECTION REPORT FORM

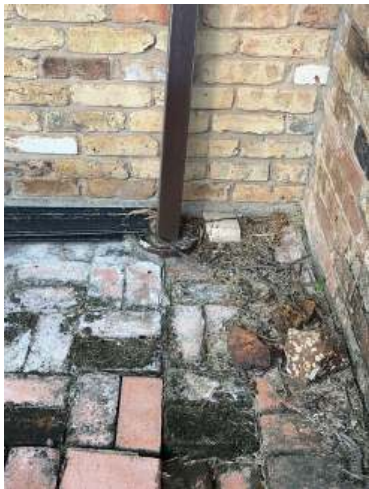
Downspout entering underground drainage pipe, unknown where the discharge is and whether or not the drainage pipe is blocked.  
Left, Side Yard

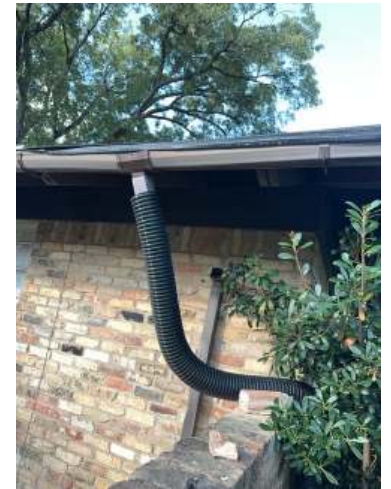
Gutter is bowed in this location, as well as the down spout being removed and a temporary re direction of the water has been installed. Recommend asking seller why this was necessary.

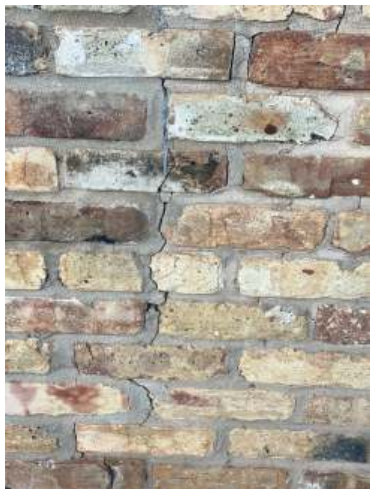
Cracking was present in the brick veneer. No displacement or visible settlement was observed with the crack at the time of inspection. Evaluation by a mason is recommended with sealing or repairs made as deemed necessary.

Crack found in the exterior brick on the left side of the home near the back. Continuing down through the foundation. Recommending evaluation by a structural engineer.  
Rear, Left, Side Yard

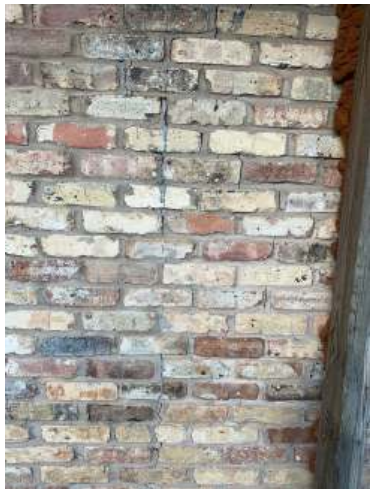
Portions of the brick veneer have moved previously and repairs have been attempted to stabilize this brick. I recommend consulting with the sellers as to who made the repairs and why along with further evaluation by a qualified mason.

Attempt to add grout to the crack in the brick veneer, unsuccessful attempt.  
Left, Side Yard

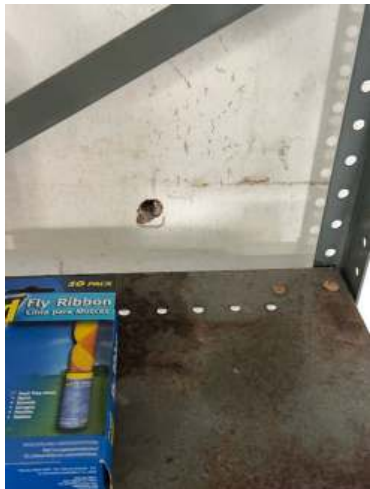
Multiple many holes like this throughout the garage. Recommend repairing to continue the fire rating in the garage.

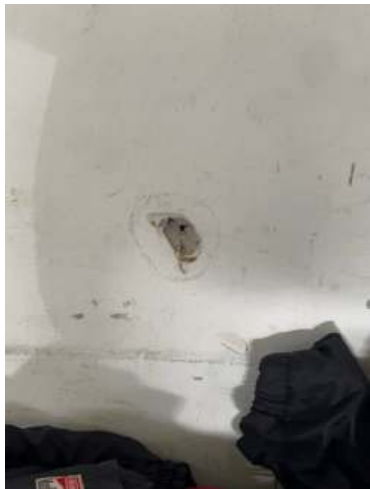
Multiple many holes like this throughout the garage. Recommend repairing to continue the fire rating in the garage.

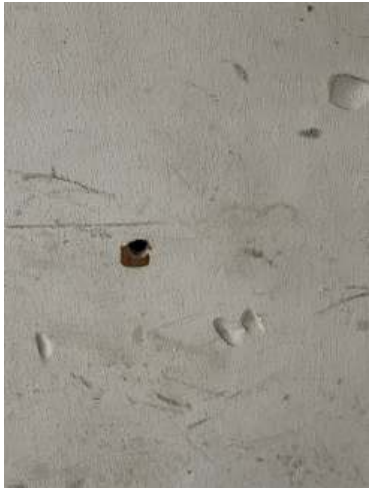
Multiple many holes like this throughout the garage. Recommend repairing to continue the fire rating in the garage.  
Garage

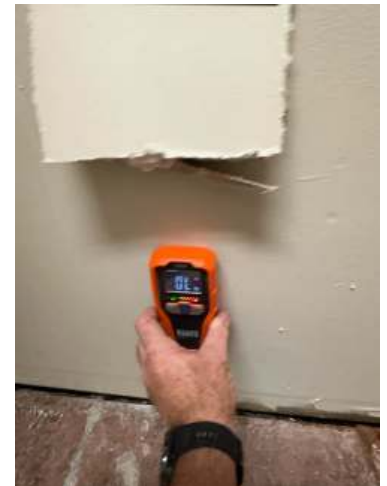
Moisture level found on the drywall in the laundry room near the leaking faucet.

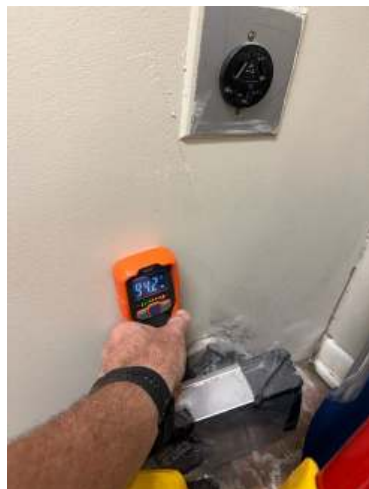
Moisture level found on the drywall in the laundry room near the leaking faucet.

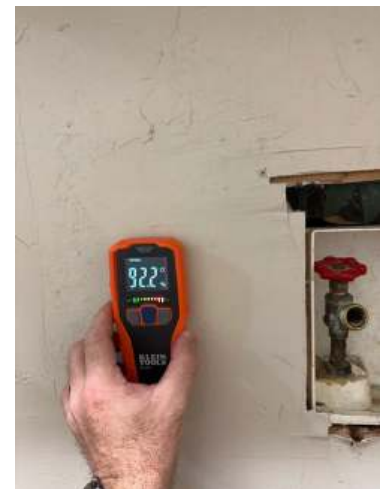
Moisture level found on the drywall in the laundry room near the leaking faucet.

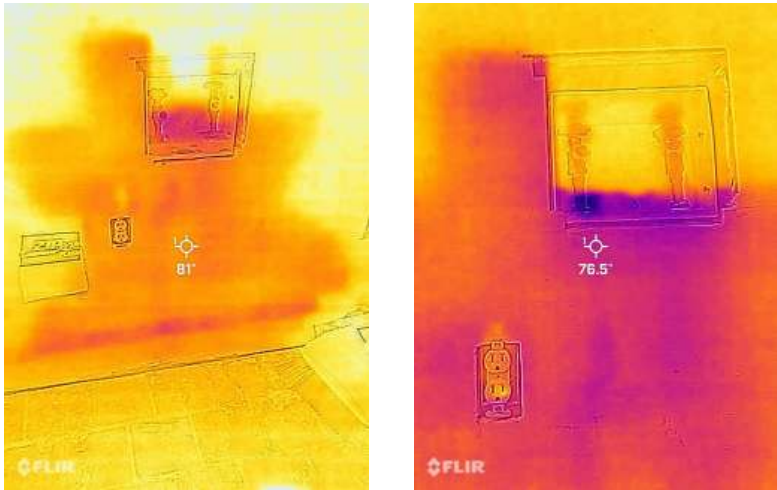
Thermal image shows the large section of drywall that is cooler than the surrounding area.

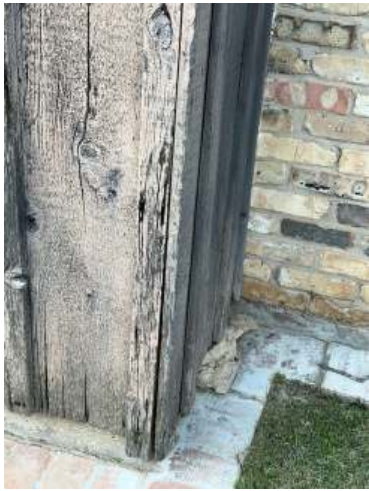
The engineered wood siding had several installation related deficiencies including but not limited to: clearance from grade, deck surfaces, and roof surfaces; the product was face nailed, missing flashings at window and door openings, thickness of corner trim, etc. This voids any warranty with the product and may allow for shortened life and wall damage. Evaluation of the install with repairs or replacement made as needed is recommended by a siding contractor familiar with LP smart side style products.

Wood trim deterioration.

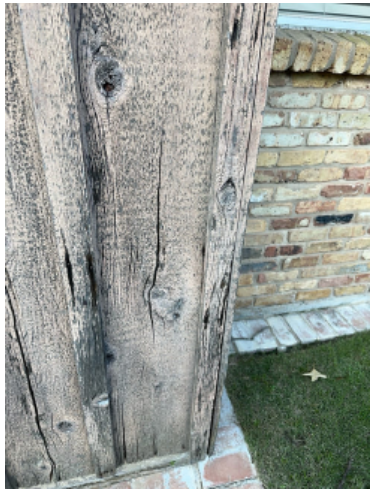
Wood siding deterioration as well as the trim work deteriorating.

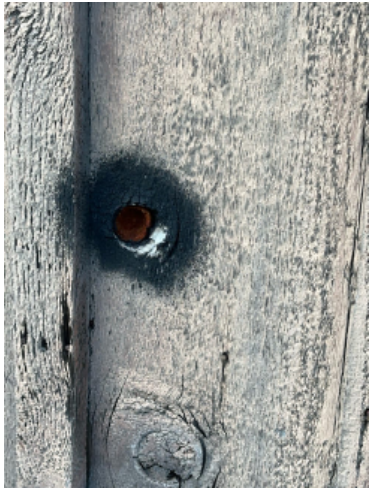
Another entry point into the house that needs to be sealed.

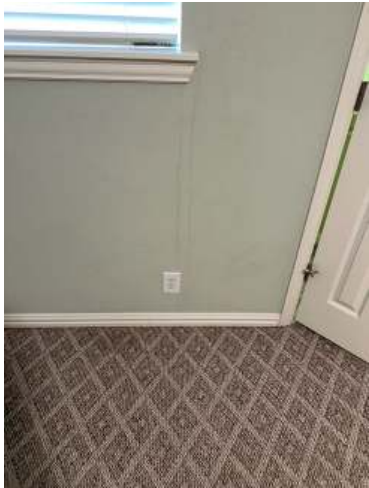
Moisture staining was present on the referenced wall. An evaluation of the wall in this area is recommended to be performed by a qualified contractor to determine the source of the staining with repairs made as needed.

Water staining is visible on the interior wall directly below the window. We recommend having a qualified contractor evaluate this area to determine the source of the moisture and make any necessary repairs.  
Bedroom 3, Left

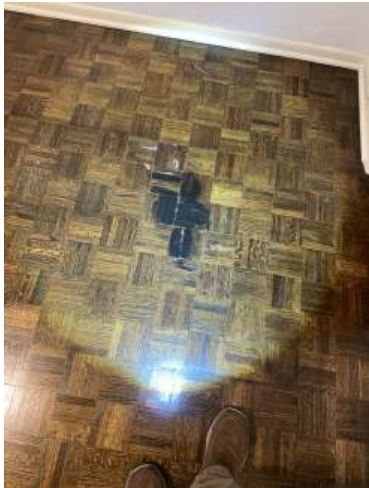
Floor damage.  
Bedroom 4

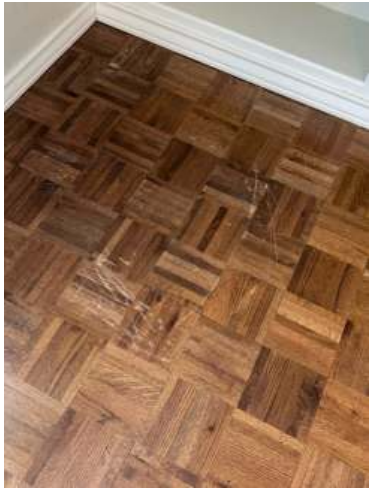
Dining room floor damage.  
Dining Room

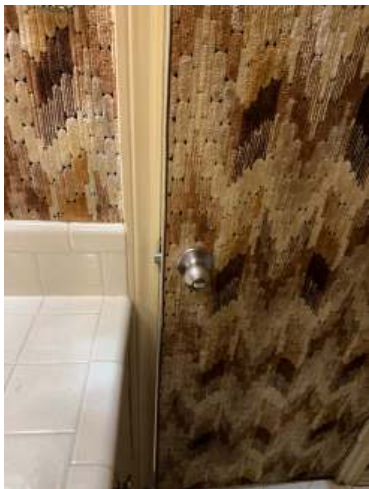
There were door(s) that were binding/rubbing on an adjacent surface. Adjustments or modifications are recommended as needed for proper operation.

The door is rubbing at the latch. We recommend adjusting or modifying the door as needed for proper operation.

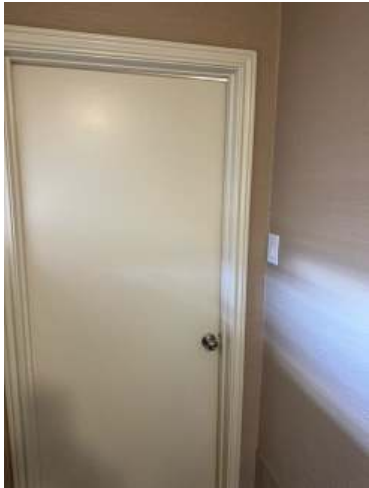
Large gap at the top of the latch side of the doo entering the front left bedroom, Bedroom 4.

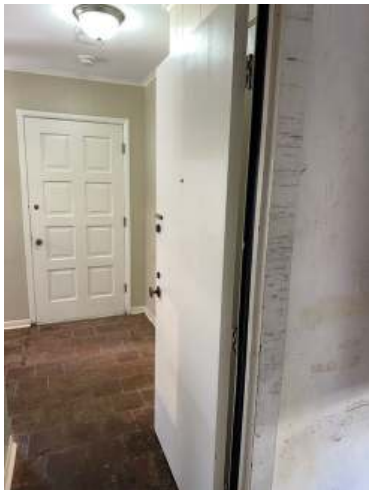
There was no self-closing device on the door between the house and the garage. It is strongly recommended that one be installed in order to protect the residence against garage originated res and CO dangers.

Recommend that self closing hinges be added to garage entry door. This was not available at the time this home was constructed, but has now been required by the IRC building code.

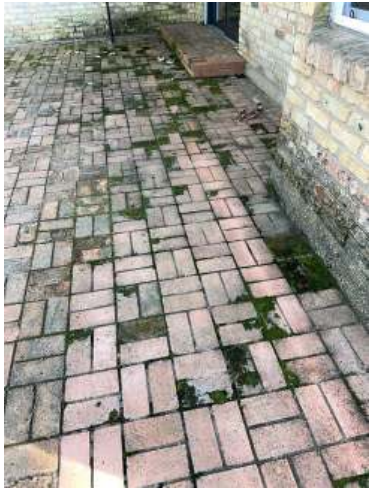
Moss growth on brick deck.  
Rear, Patio

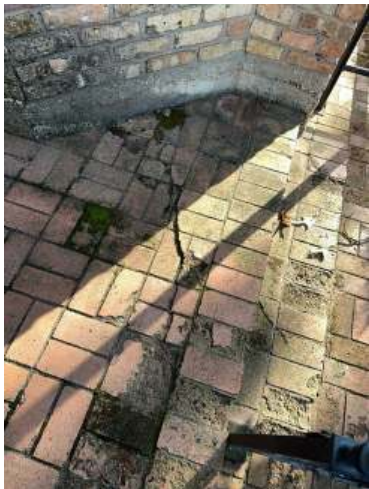
There was minor cracking present on the masonry below the concrete slab porch. This is most likely associated with some degree of settlement. I recommend monitoring this area with the understanding that future repairs may be needed if further movement occurs.

Minor settling of the rear porch at rear left side of the home. Recommend monitoring for activity.  
Back Yard, Patio

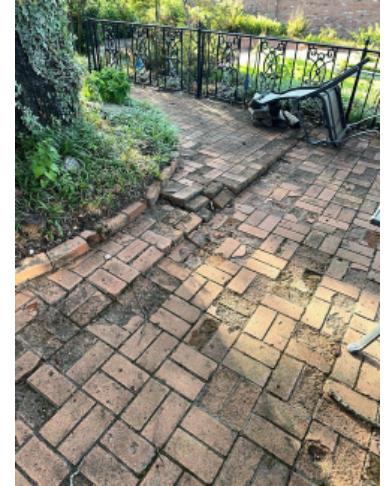
Large uplift of the brick pavers on the driveway side of the tree in the back yard.

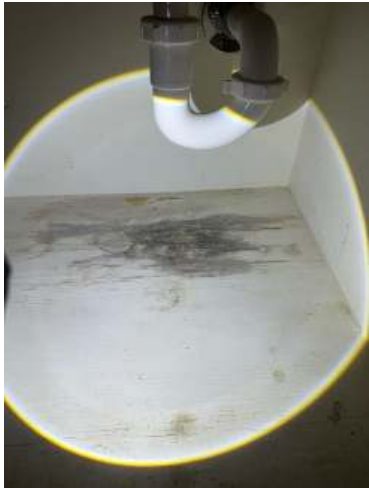
Fungal growth was observed at the back of the sink cabinet. We recommend having a qualified professional evaluate and address this issue.  
Bathroom, Hallway

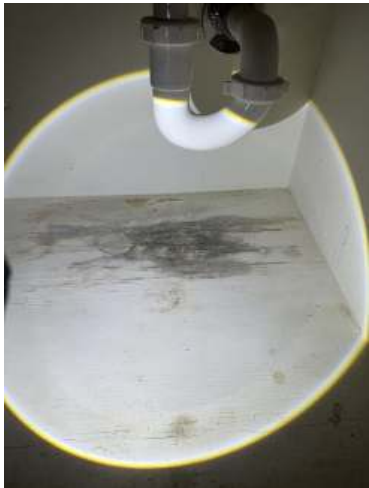
Biological fungal growth in base of cabinet.  
Hallway Bathroom

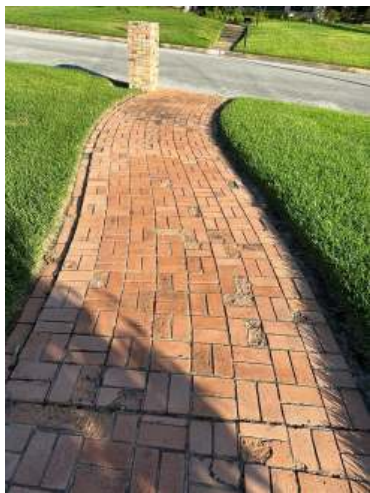
Brick pavers are spalling and settling down the entire path. Rebuilding the walkway base is recommended.  
Front Entrway

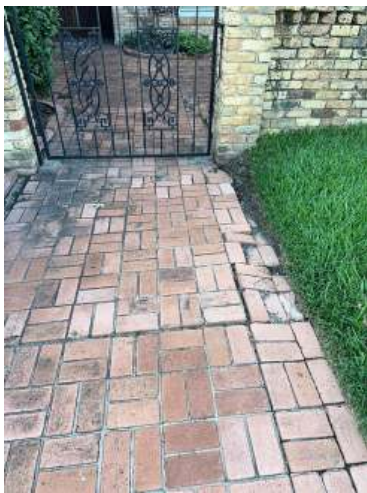
Brick pavers are spalling and settling down the entire path. Rebuilding the walkway base is recommended.  
Front Entrway

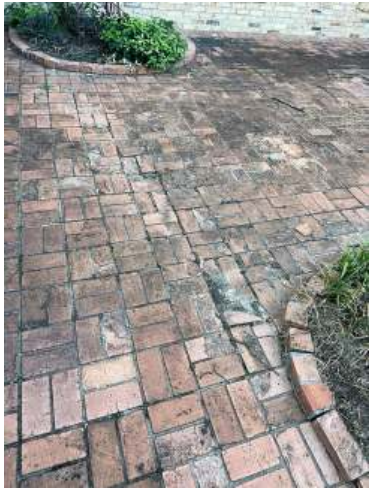
Brick pavers are spalling and settling down the entire path. Rebuilding the walkway base is recommended.

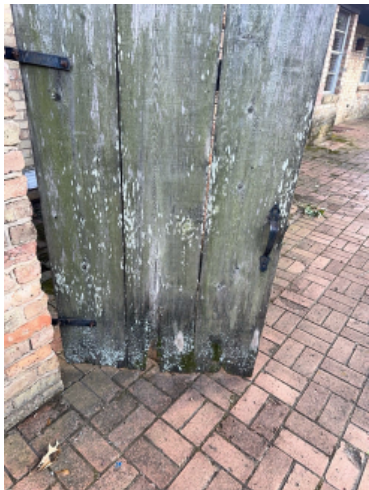
Wooden gate doors are deteriorating, recommend replacing the boards.  
Rear, Entry, Patio

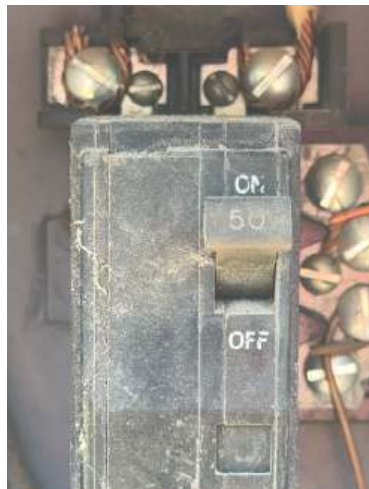
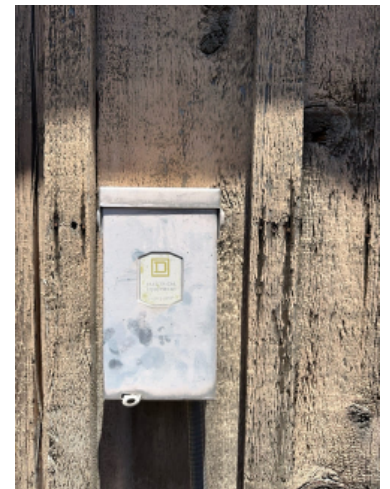
The exterior HVAC unit was protected by a breaker larger than the maximum designated sized breaker as found on the exterior unit's data tag. The installation of the proper sized breaker as needed is recommended to be conducted by a licensed electrician.

During the inspection, we observed that this 50-amp breaker at the exterior HVAC unit is oversized. It exceeds the maximum designated breaker size specified on the Left, Side Yard

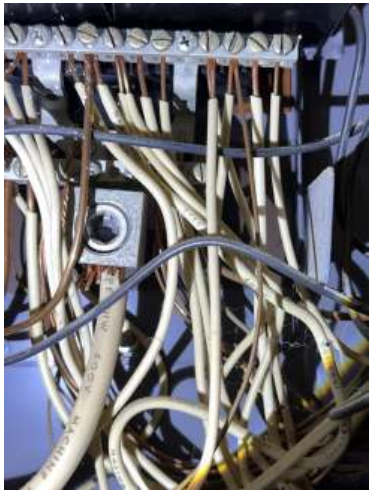
Photo of double tapped neutral wires in panel.

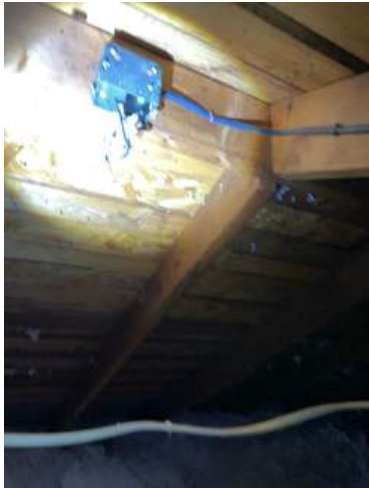
Electrical wires hanging out of a junction box in the attic with no wire caps, unknown if these wires are live.  
Attic

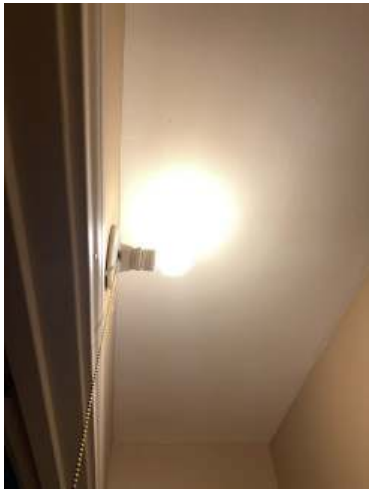
Protective cover recommended to protect light bulb from being damaged or broken.  
Hall Closet, Closet, Bedroom 2, Bedroom 3, Bedroom 4, Primary Bedroom

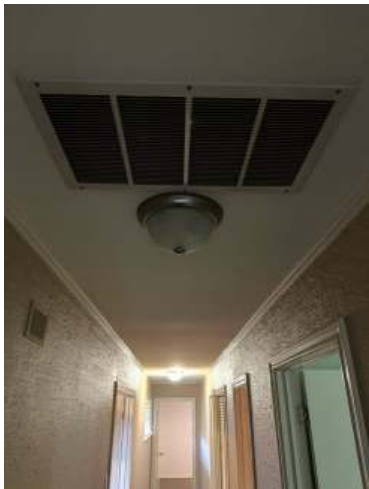
The referenced light(s) did not respond to the switch at the time of inspection. This could be as simple as burned out or missing bulb(s), or an unknown switch that controlled them. This could also be more extensive and represent a deficiency with the fixture, wiring, and/or switch. We recommend having the seller(s) replace the bulb(s) and confirm proper operation prior to the end of your inspection contingency period, if the fixture(s) can not be confirmed to be functional, repairs are recommended to be performed as needed for proper operation by a licensed electrician.

Bulb burnt out, replacement is recommended.

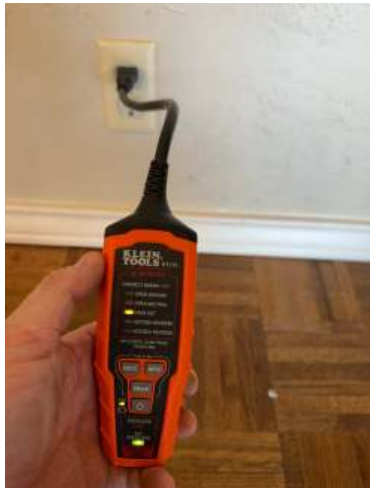
There were receptacle(s) present in the referenced area(s) that were not functional at the time of inspection. These may be associated with a "tripped" GFCI receptacle or an unfound switch, if so the tripped receptacle or switch was not found. Repairs or replacement as needed for proper operation is recommended to be performed by a licensed electrician.

No power to the outlet, recommend electrician to evaluate and repair.  
Dining Room

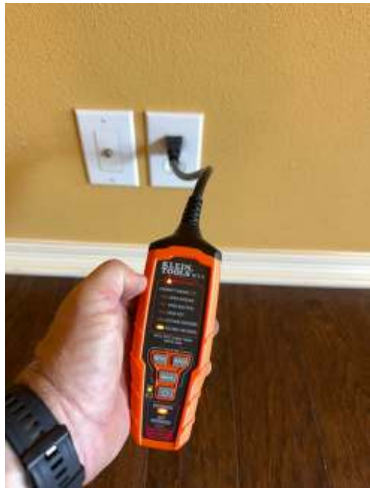
An outlet tester indicates a hot/neutral reverse wiring condition at the primary bedroom exterior wall facing the backyard. Repairs by a licensed electrician are recommended.  
Primary Bedroom

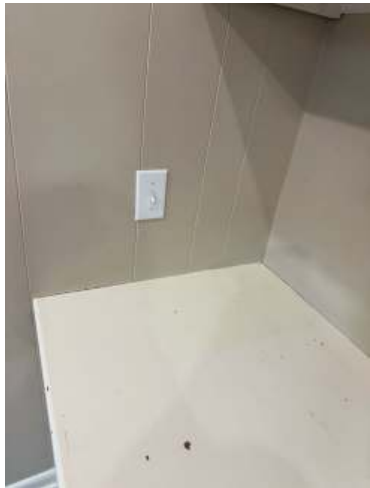
There were switch(es) present that were not functioning properly at the time of inspection. Repairs or replacement as needed is recommended to be performed by a licensed electrician for proper operation.

Unknown if this switch is working for the built in desk in the living room. there are lights under the cabinets above that could not be turned on.  
Living Room

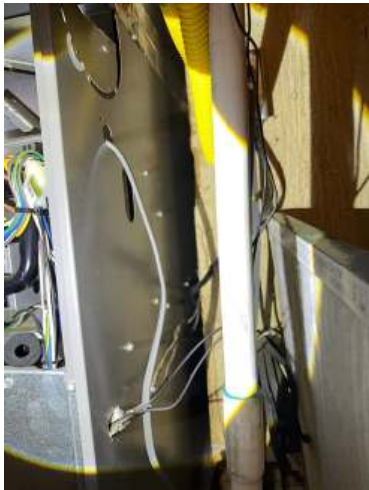
Here we can see a missing or displaced bushing where the wire enters the heating equipment cabinet. This can lead to wire abrasion over time. We recommend having a licensed electrician evaluate and install a Hallway, HVAC

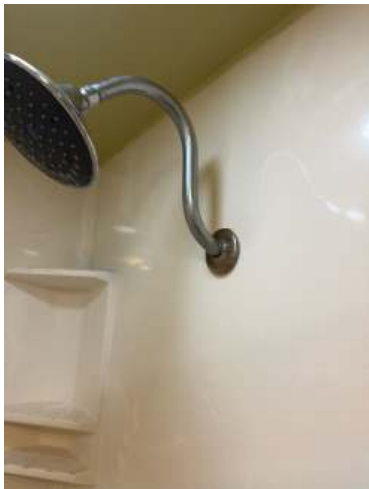
Shower head loose in the wall. Not leaking.

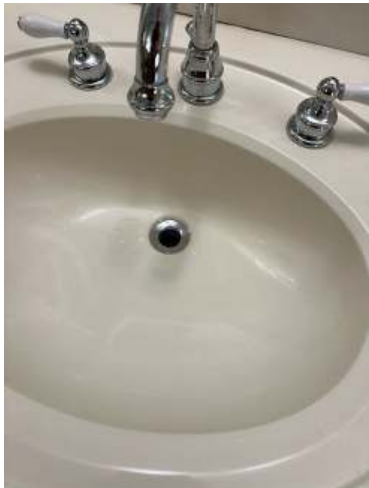
The sink stopper is missing, and we recommend having a qualified person install a compatible replacement to restore full functionality.

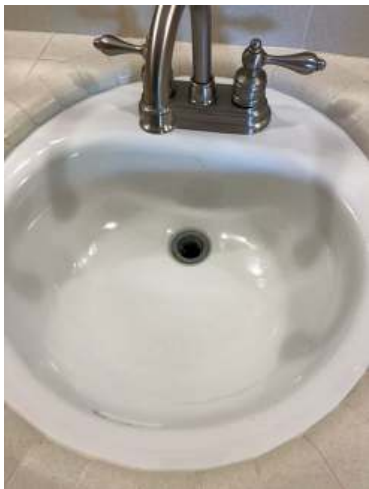
The bathroom sink is missing its drain stopper, and we recommend having a qualified person install a replacement.

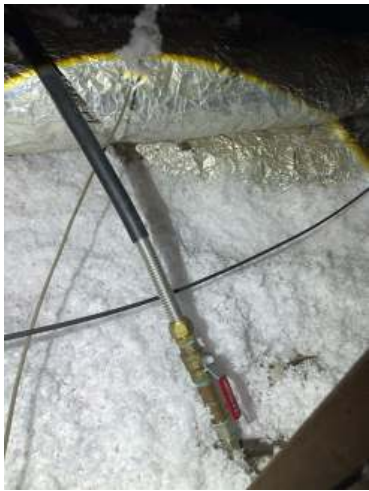
CSST plumbing found in the attic, recommend having an electrician verify a bonding wire is connected or having a bonding/grounding installed.

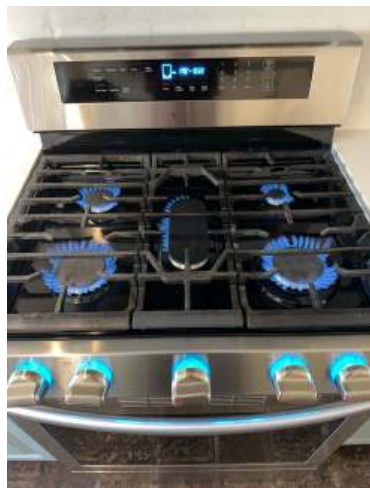
During the kitchen inspection, we noticed that not all of the burners on the gas range were operating at their full potential. Specifically, some gas burners were not producing a flame all the way around the burner

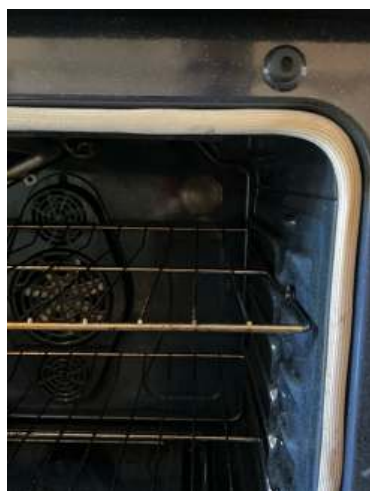
The oven light was not operational during the inspection. I recommend replacing the bulb or further evaluating the unit to ensure proper operation.
