## Cardinal Home Inspections

# HOME INSPECTION REPORT

# PROPERTY INSPECTION REPORT FORM

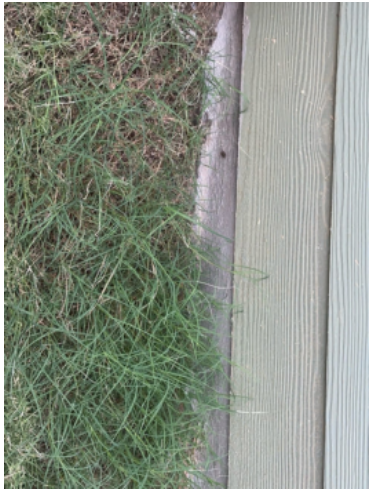
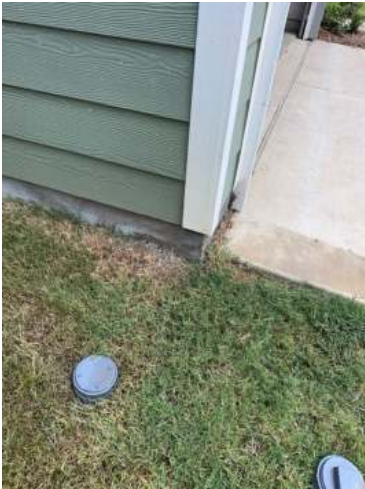
1: Slab Perimeter: Parged in Areas

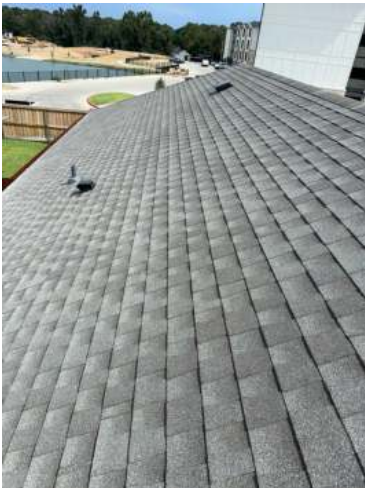
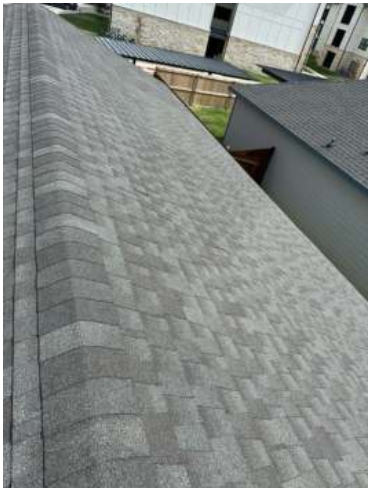
Roof

1: Boot Flashing(s): Improper Shingle Coverage

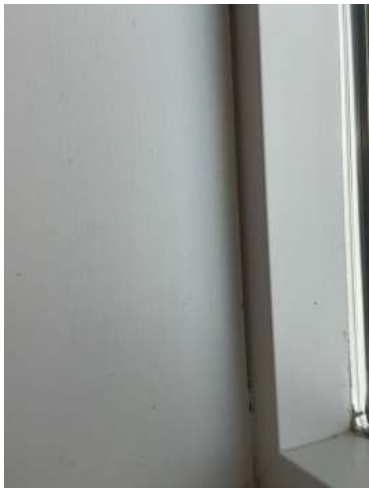
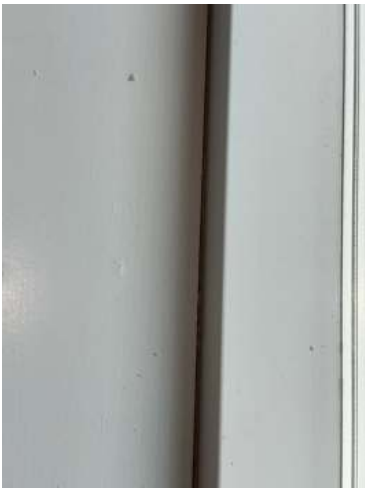
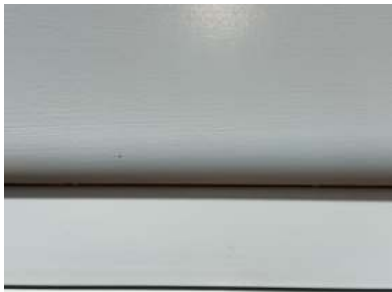
Living Room

This omission can allow drafts, moisture intrusion, and potential energy loss.

Recommendation: Install appropriate cork or weather-stripping to restore a continuous seal and protect against moisture and air infiltration.

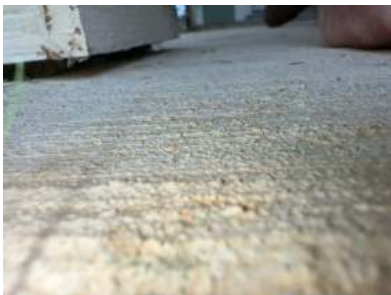
Porch Back

The porch support post was observed in direct contact with the concrete footing, creating a continuous moisture path between the wood and the foundation.

**Recommendation:** Install a suitable moisture barrier or provide a physical separation (e.g., pressure-treated spacer) between the post and concrete to mitigate potential rot or decay. This condition can accelerate deterioration if left unaddressed.

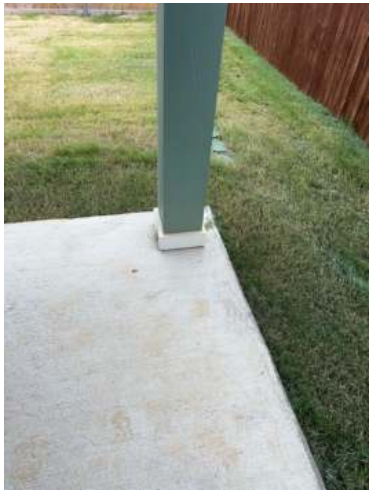
These openings can allow ground moisture to wick into the wood, increasing the likelihood of rot and compromising structural integrity. **Recommendation:** Install an approved Barrier between Wood post and Concrete.

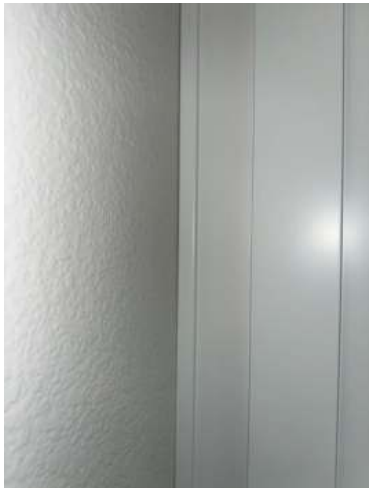
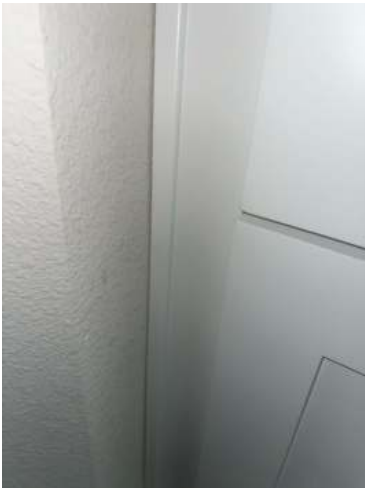
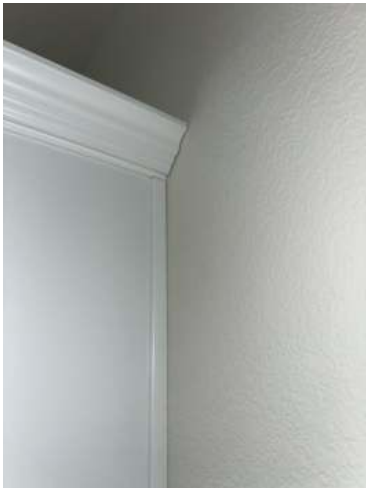
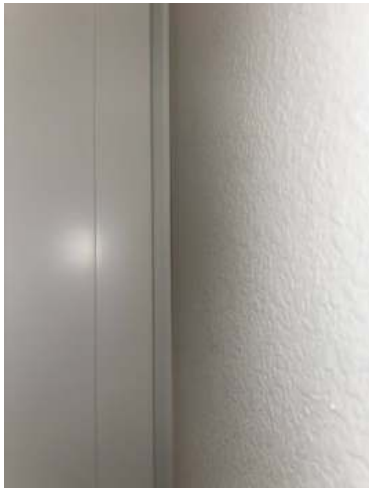
Kitchen

During the inspection, it was observed that the caulking seal between the **cabinet base** and the adjacent wall is missing. The absence of a continuous seal can allow moisture to penetrate the joint, potentially leading to water damage, mold growth, or deterioration of the cabinet finish over time.

Recommendation: Apply a suitable interior-grade caulk to re-establish a water-resistant seal.

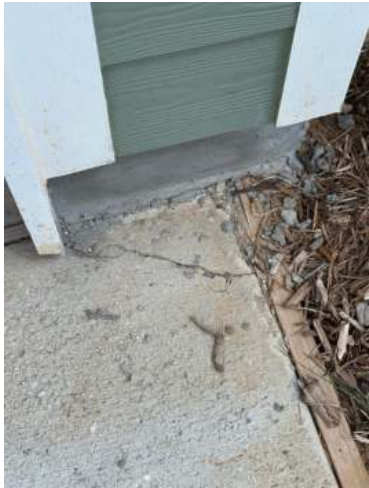
**3: Concrete - Area(s) of Damage**

There were areas of damaged concrete present at the referenced area(s). An evaluation and repairs as needed is recommended to be performed by a concrete contractor.

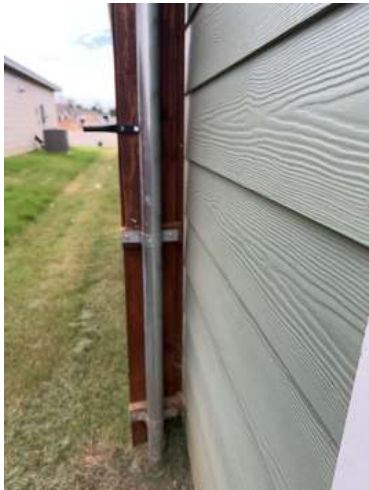
1: Wooden Fence in Contact with the Structure

The wooden fence is in contact with the structure in various areas.

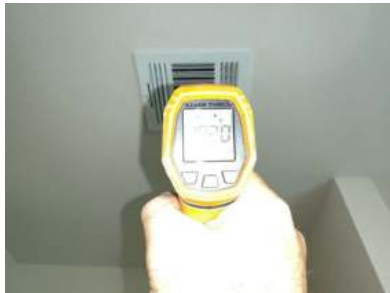
102 degrees

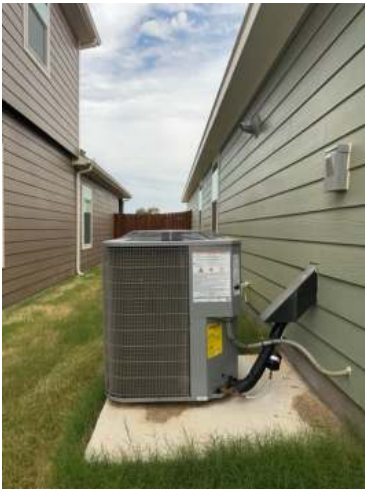
Not level  
Left Side Yard

The exterior unit was not level. This can put strain on the fan motor, prevent proper lubrication of the compressor, affect system performance, and may void the warranty for the system. Properly leveling the unit and/or pad is recommended to be conducted by an HVAC contractor or other qualified person.

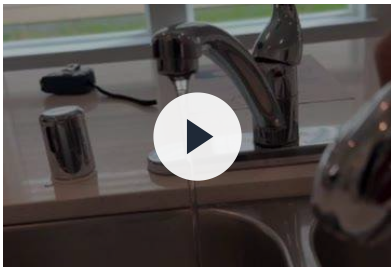
Kitchen

An irregular water stream was present from the faucet. The aerator may need replacement. Evaluation and repairs as needed for proper operation is recommended by a qualified person.

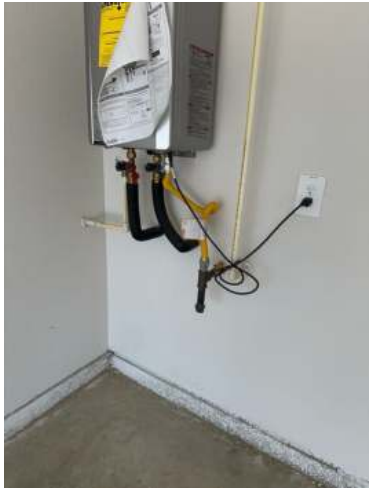
Garage

A water heater drain pan was not present. Drain pans also called "Smitty pans" are recommended when the water heater is installed in an area where leaks from the unit could cause damage to framing components and/or interior areas. The installation of a drain pan is recommended.

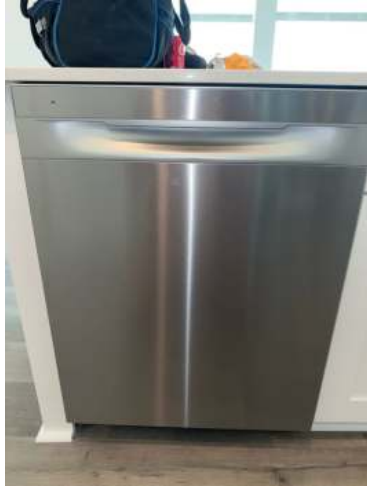
The dishwasher was operated by running a wash cycle and was functional at the time of inspection. No leaks or water was present at the base of the unit at the completion of the cycle. The unit's efficiency of cleaning dishes is not tested. No deficiencies were observed with the unit unless otherwise noted in this report.

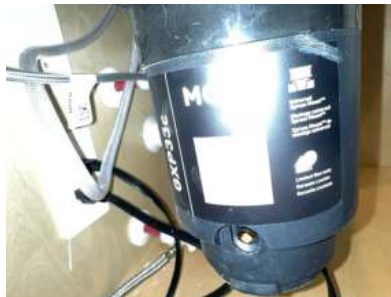
The garbage disposal was inspected by activating it at normal controls and ensuring the motor ran, while also looking for leaks from the unit, an exposed power cord, heavy rust, or other deficiencies. The unit is not tested to determine if it can effectively "grind" food waste. No reportable conditions were present at the time of inspection unless otherwise noted below.

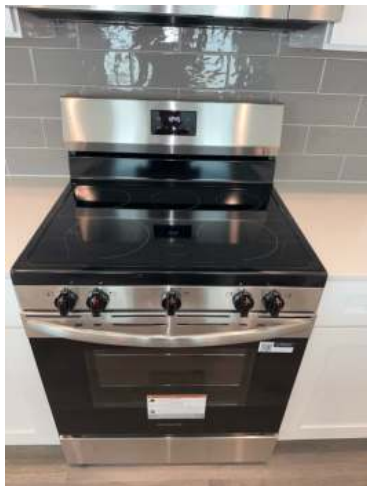
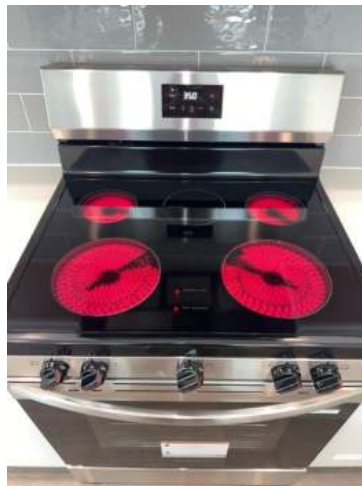
**1: RANGE**

All of the heating elements on the range were turned to "High", and were functional at the time of inspection, unless otherwise noted in this report. The oven was operated by placing into "Bake" mode at 350F, and heat was produced

from the burner(s) and/or elements. The timer and oven light are tested for functionality. "Clean" options, and other functions are not tested. No indications of deficiencies were observed at the time of inspection, unless otherwise noted in this report.

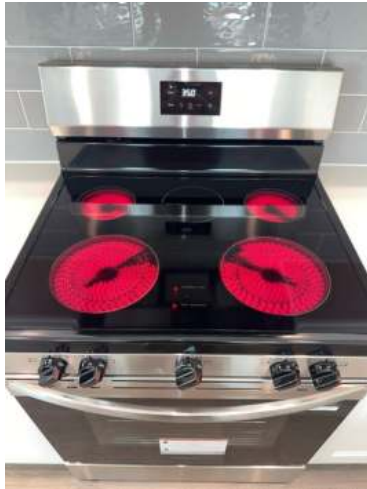
### 3: Oven: Inspection Information (Electric)

The oven was operated by placing into "Bake" mode, and heat was produced from the element(s). Temperature calibration, "clean" options, and other functions are not tested for. You are recommended to seek further evaluation of additional functions if desired/needed. No indications of deficiencies were observed at the time of inspection, unless otherwise noted in this report.

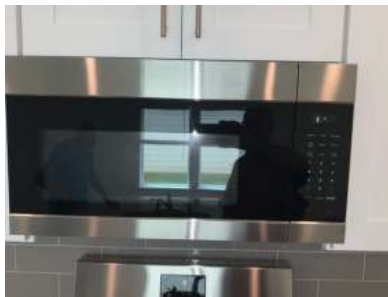
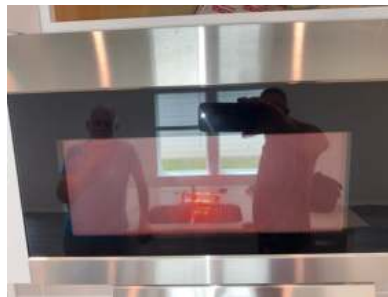
The microwave was tested by initiating it on "Cook" mode, and the unit powered on at the time of inspection. The efficiency of the unit or other functions are not tested for. No reportable conditions were present unless otherwise noted in this report.

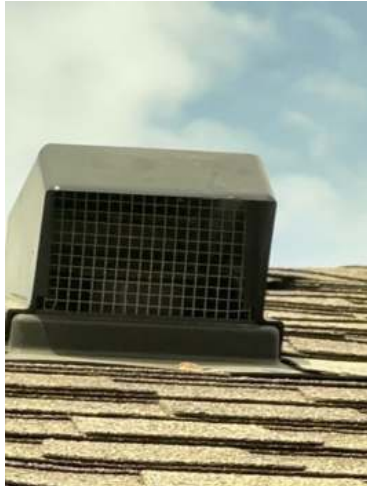
There was a screen present on the exterior of the dryer vent, this screen can collect lint and be construed as a possible fire hazard. Removal of the screen is recommended.

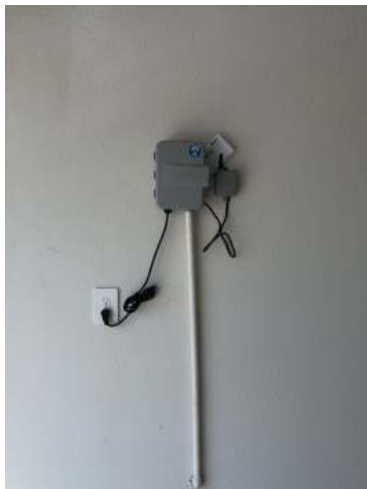
### 1: Sprinkler System Information

In the inspectors' opinion, the sprinkler system appeared to be in **serviceable condition**. Functioning at time of inspection.

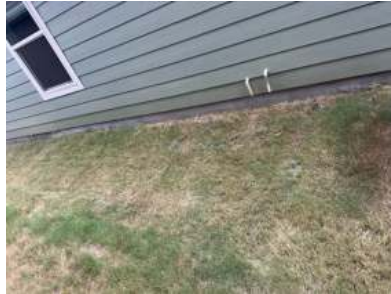
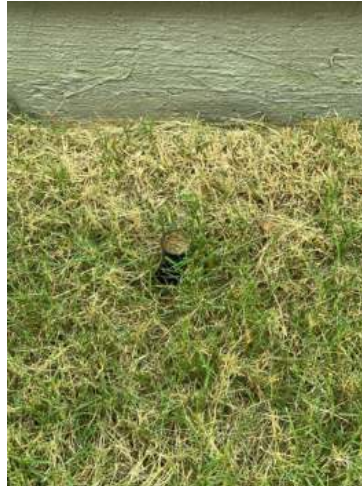
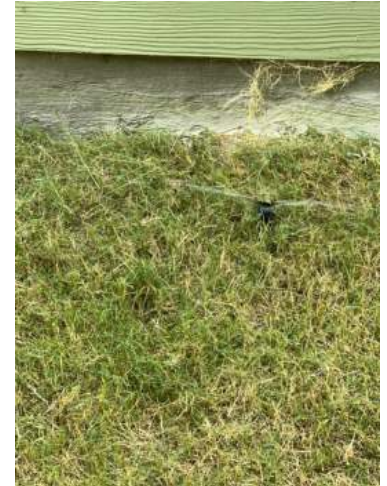
15: Sprinkler head needs adjustment/repair

There are one or more sprinkler heads that are in need of adjustments or repair in the yard of this home. We recommend that a licensed sprinkler technician be contacted to make repairs as needed. Sprinklers should not spray on walls or on flat work.
