## Cardinal Home Inspections

## HOME INSPECTION REPORT

# PROPERTY INSPECTION REPORT FORM

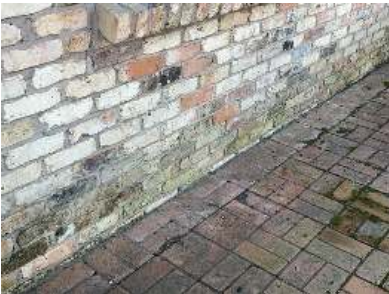
During the exterior inspection of the foundation, the brick veneer at the base was found to lack the required **weep holes**. Weep holes provide a drainage path for moisture that penetrates the brick assembly, allowing water to escape from the interior wall cavity. Their absence can cause moisture to accumulate behind the veneer, increasing the potential for moisture-related deterioration of the foundation wall over time.

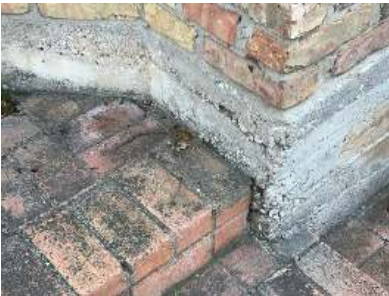
Some signs of structural movement/settlement observed; however foundation is supporting structure at time of inspection.

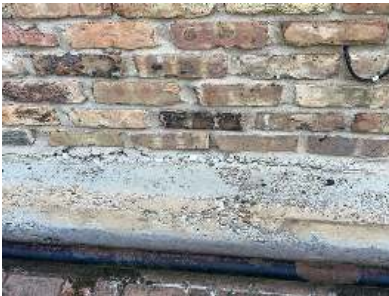
Exposed aggregate is visible along the exterior foundation wall. We recommend applying a concrete smoothing coat to protect the exposed rocks from water penetration and freeze-thaw damage.  
Rear

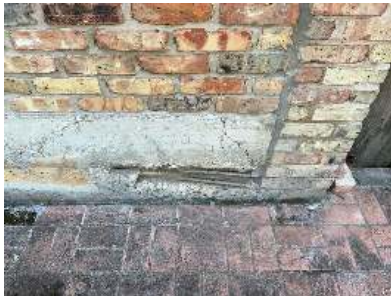
Exposed rebar  
Left, Rear

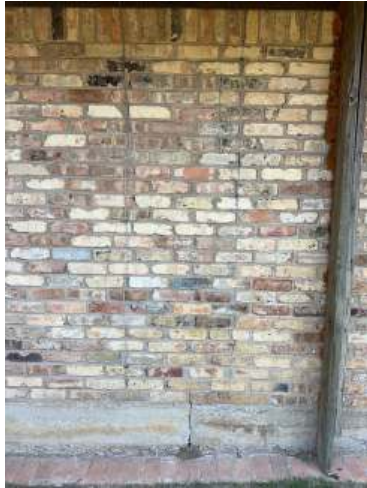
Left

We observed a crack in the foundation and recommend having a structural engineer evaluate this area.

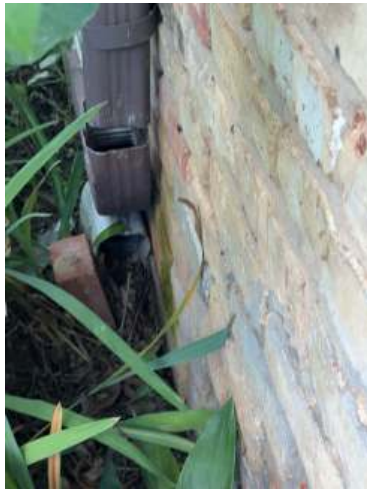
Front Middle

Multiple deficiencies were present with the gutters and downspouts. Due to this a full evaluation of the gutter system is recommended to be conducted by a guttering contractor with repairs or replacement made as needed.

Downspout disconnected from 90 degree bend, this can allow water to go directly to the foundation and undermine it over a period of time.

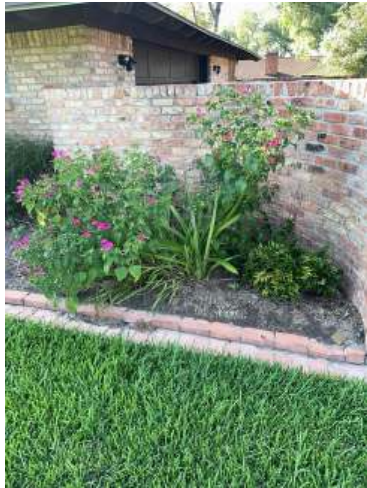
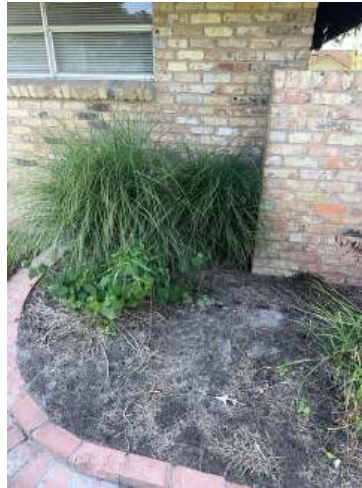
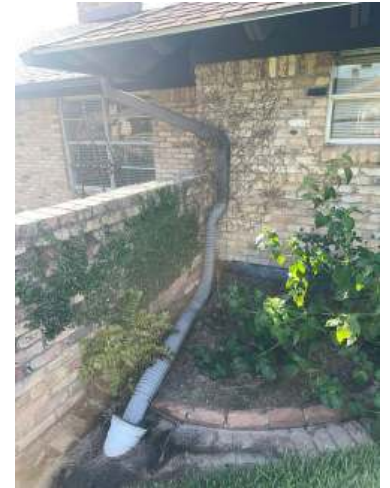
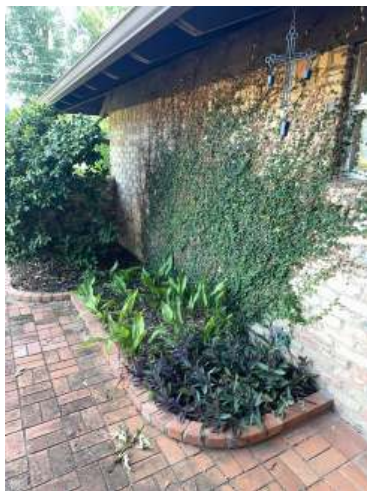
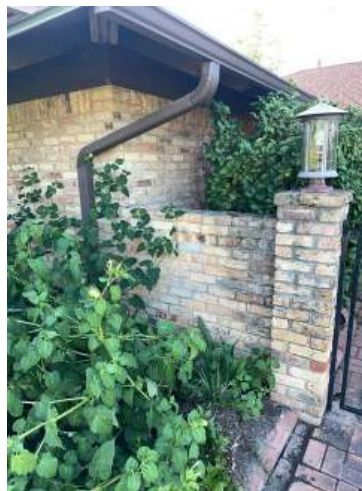
The vegetation in areas around the home was heavily overgrown. This can include trees and large shrubs in contact with the structure and/or roof. Vegetation in contact with the structure is a pathway for insects to reach the structure, and vegetation in contact with the roof can cause damage to the shingles by abrasion, as well as filling gutters with organic debris, impeding drainage. Pruning and removal of this vegetation as deemed necessary by a landscaping contractor is recommended.

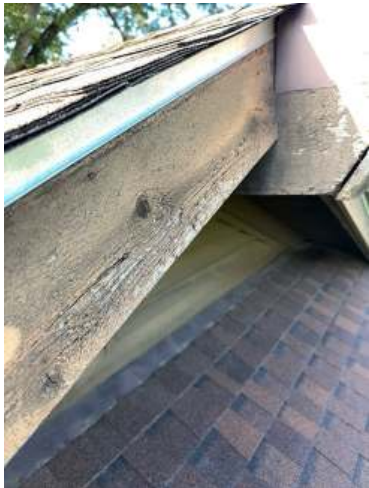
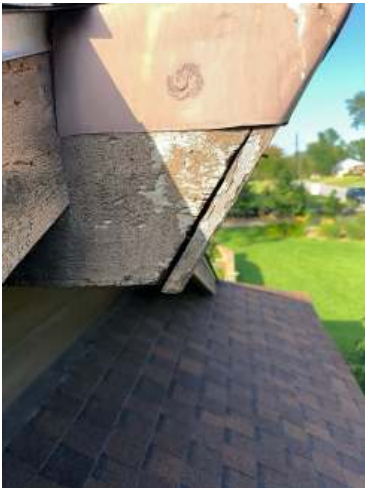
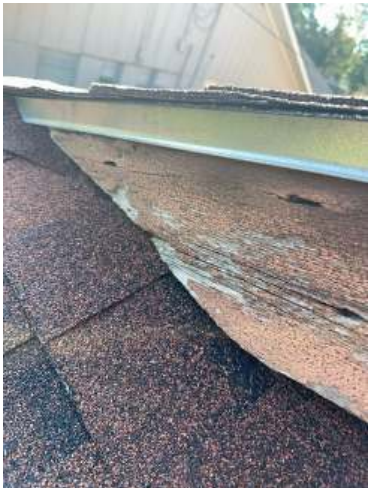
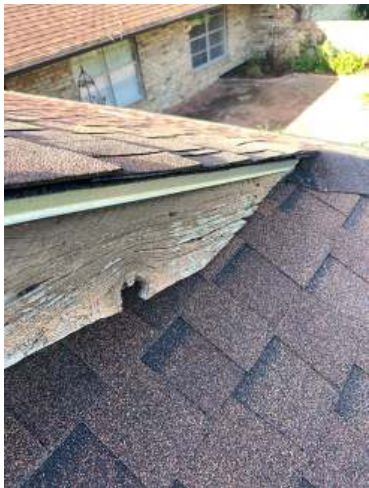
The fascia at (location) is damaged/deteriorated. Recommend a qualified professional repair/replace the fascia in all areas where it is damaged/deteriorated to prevent further damage/deterioration and, if damage is significant enough, potential pest and rodent entry.

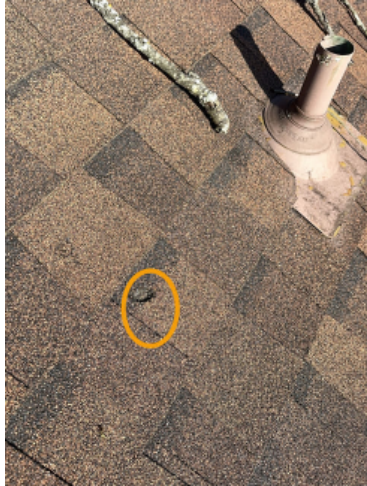
Left, Roof

Damaged/missing shingle(s) observed at referenced area(s) in need of repair/replacement.

Damage to shingle, most likely from a fallen limb from the tree.

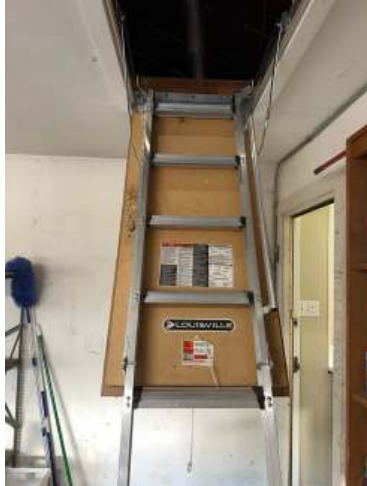
Garage

Attic ladder, not fire rated.

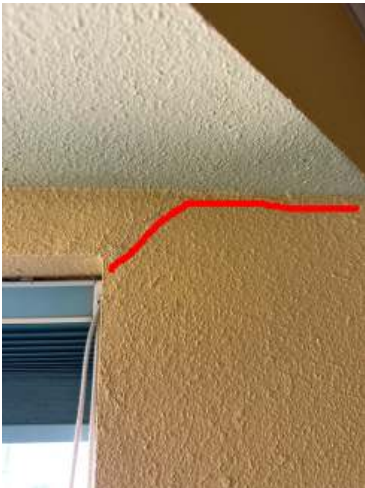
The line should help to find the crack in the drywall at this location. Recommend to monitor this area for any changes.

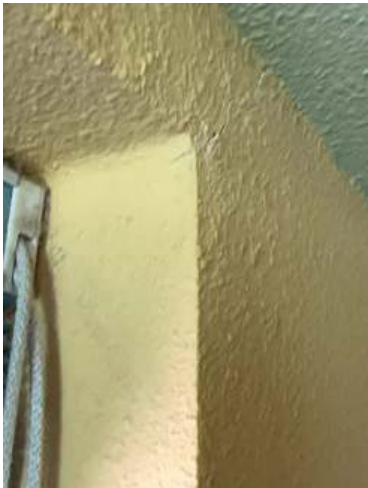
Drywall crack found above window in the primary bedroom adjacent to exterior brick crack on the exterior of the home.  
Primary Bedroom

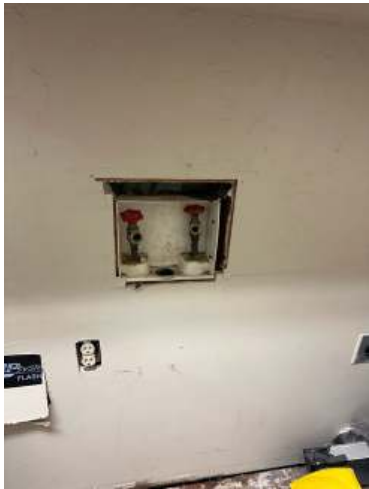
Laundry Room

Missing trim

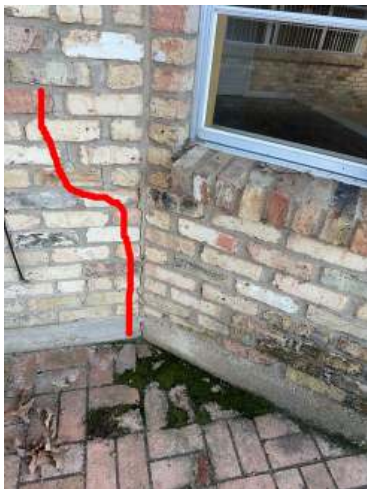
Rear, Back Yard, Exterior Walls

7: Brick Veneer: Previous Repair (Due to Movement)

Portions of the brick veneer have moved previously and repairs have been attempted to stabilize this brick. I recommend consulting with the sellers as to who made the repairs and why along with further evaluation by a qualified mason.

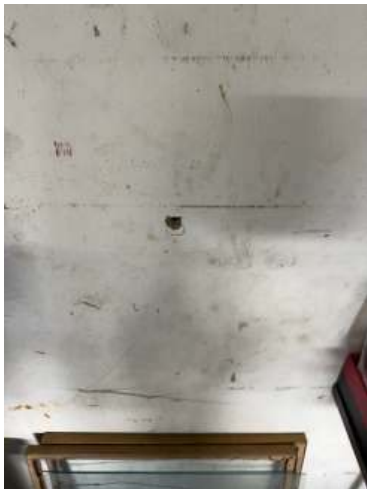
Multiple many holes like this throughout the garage. Recommend repairing to continue the fire rating in the garage.

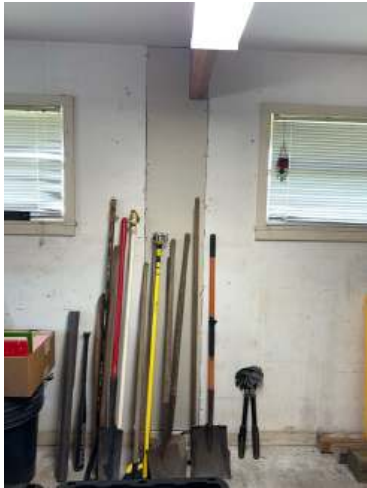
Large drywall patch that has not been finished. If a fire were to start in the garage, it would have an easy path to the attic space. Like patch on opposite wall.  
Garage

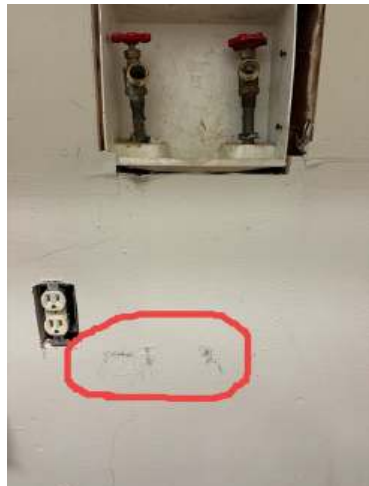
Visible biological fungal growth on exterior side of the drywall in the laundry room. Faucet on the left side found leaking. Laundry Room

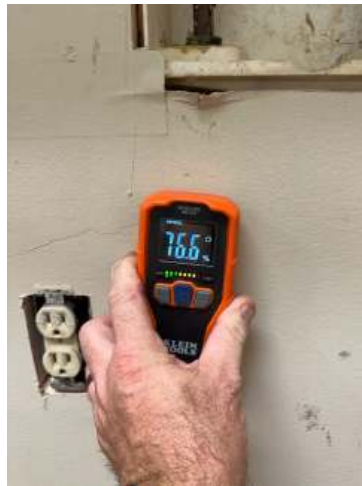
Moisture level found on the drywall in the laundry room below the leaking faucet.

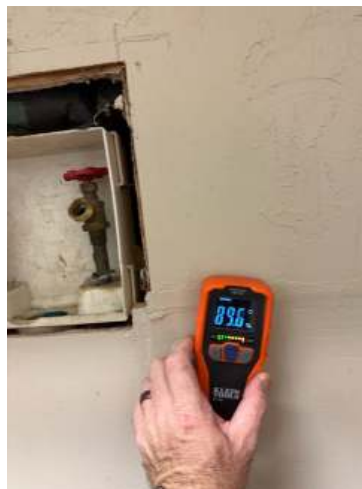
Moisture level found on the drywall in the laundry room near the leaking faucet.

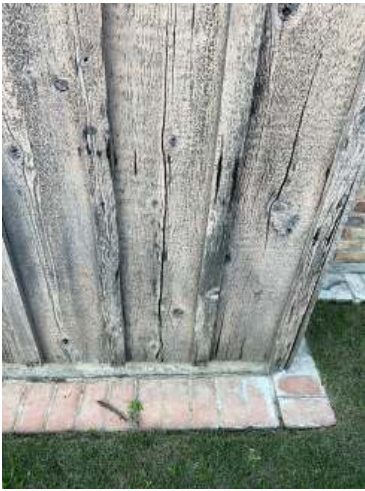
Wood siding deterioration.

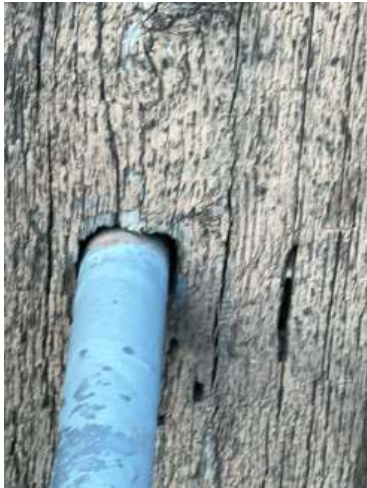
Gas line entering the house. Recommend caulking this entry point to stop moisture and insects from entry into the home.  
Left, Side Yard

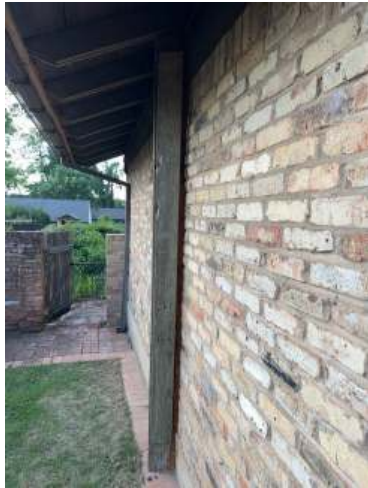
Unknown board spray foamed to the side of the house. Unknown reason for it to be there. Not structural.

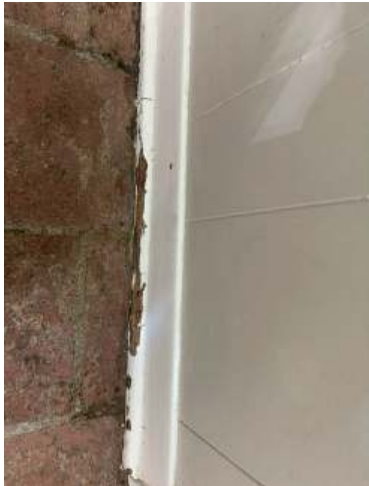
Wood trim deteriorated. Recommend repair.  
Eat in Kitchen

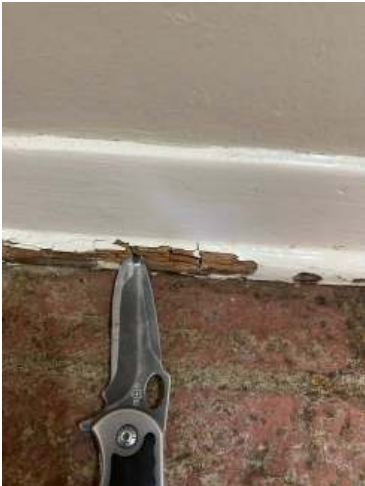
Knife point easily enters the wood trim piece.

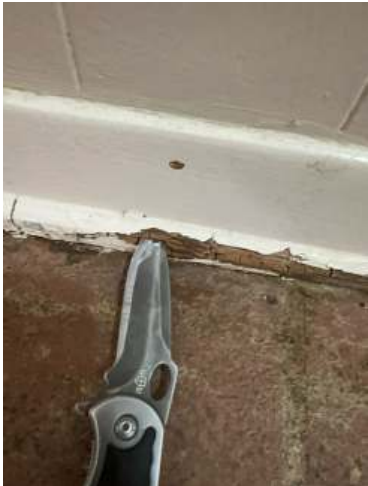
Knife point easily enters the wood trim piece.

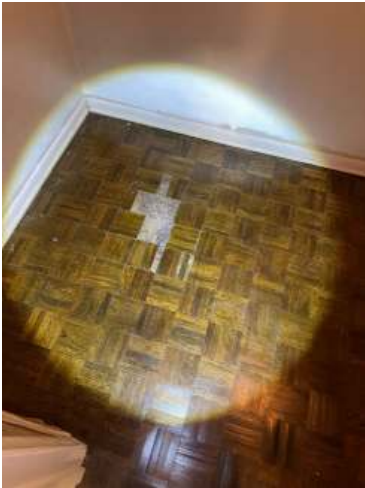
Floor damage in closet.  
Bedroom 4, Bedroom Closet

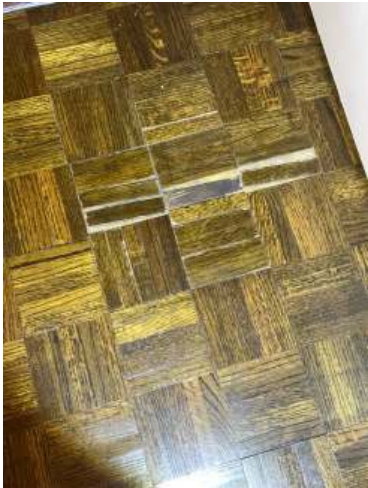
Floor damage in closet.  
Bedroom 4, Bedroom Closet

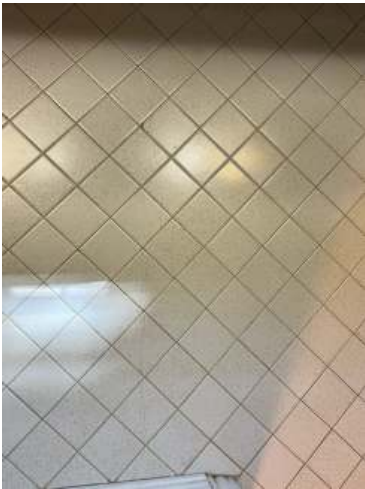
Jack and Jill Bathroom floor tile cracking  
Jack and Jill Bathroom

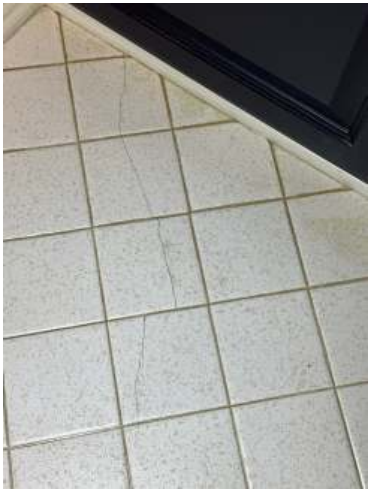
Cracked floor tiles observed in the Jack and Jill bathroom water closet. Recommend evaluation and repair by a qualified professional.  
Jack and Jill Bathroom

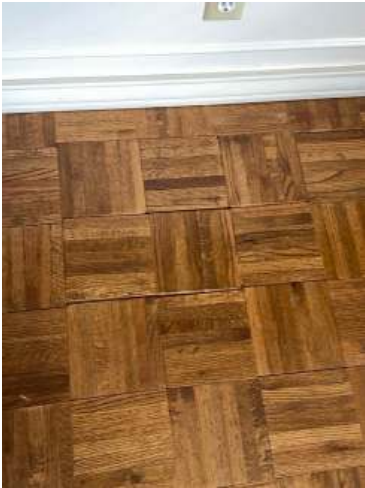
We observed loose flooring in the dining room. We recommend having a qualified contractor evaluate and repair this area.  
Dining Room

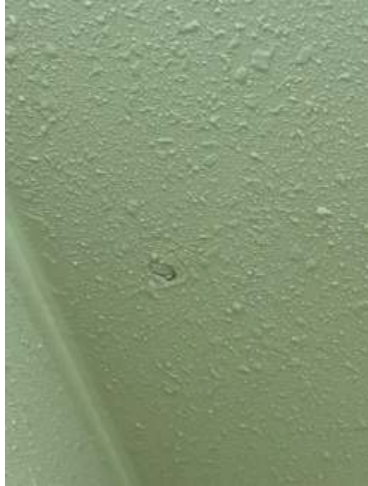
Bedroom 3, Bedroom Closet, Closet

We observed a nail pop on the bedroom closet ceiling. We recommend having a qualified contractor repair this area as desired.

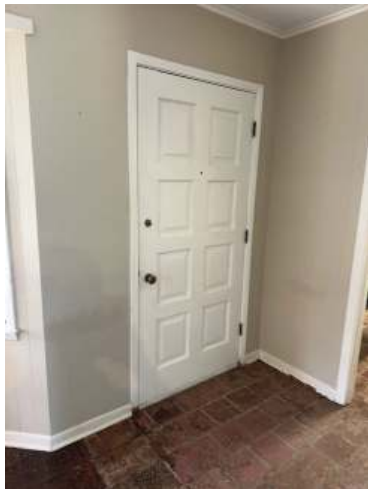
The kitchenette and laundry room were inspected during the visit. The backyard exit door was difficult to deadbolt without pushing hard. This is a safety hazard as it may prevent the door from being secured properly. Evaluation and repairs are recommended by a qualified person to ensure the door latch and deadbolt operate smoothly.

*This rear exit door and the front door both need to be press closed in order to lock the deadbolt. Recommend the doors be adjusted so it is easier to lock them.*  
Main Entry, Eat in Kitchen

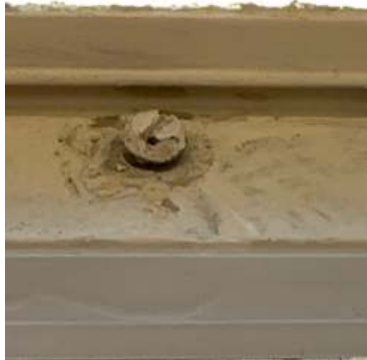
Dining Room

There were windows present in the referenced area(s) with missing and/or damaged window latches or locks. Repairs are recommended to be performed as needed for security by a qualified person.

Example fo missing lock hardware on the window.

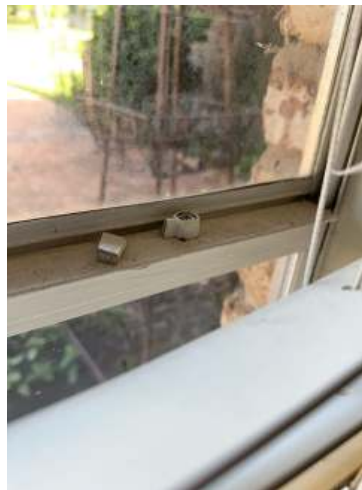
Dining Room

Lock broken.

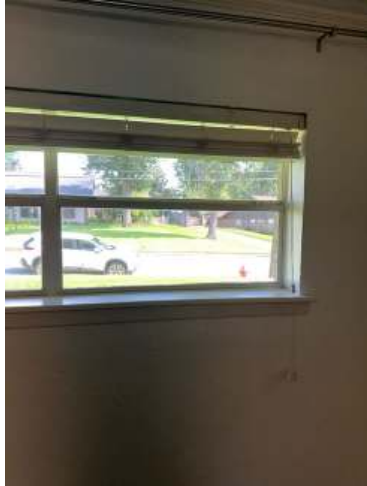
Bedroom 4

The window shown here is stuck closed and inoperable. We recommend having a qualified contractor repair it to ensure proper operation.

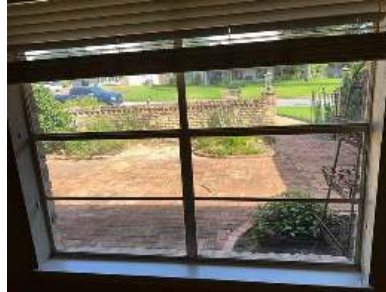
Living Room

This window is painted shut and has broken locks. We recommend having a qualified contractor repair these issues to ensure proper operation.

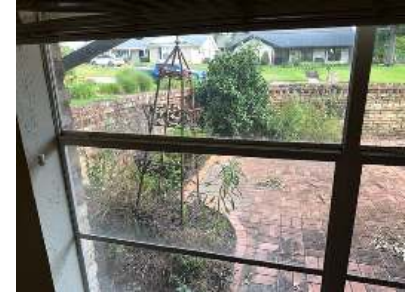
Living Room

The window has a broken lock and cannot be secured. We recommend having a qualified contractor repair or replace the lock.

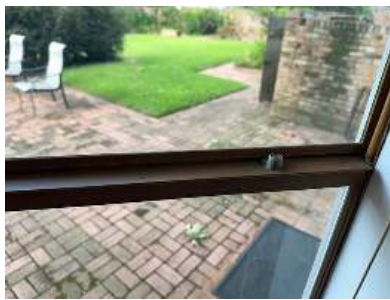
Eat in Kitchen

Broken window lock

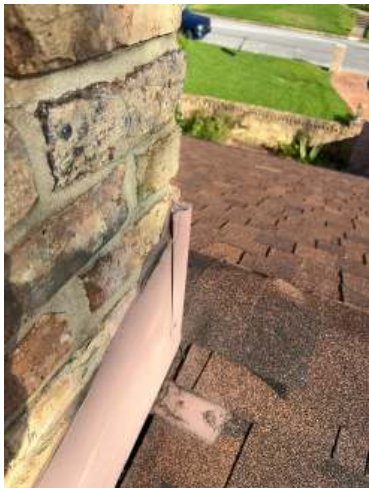
Caulking upgrade on the flashing around the fireplace chimney.  
Roof

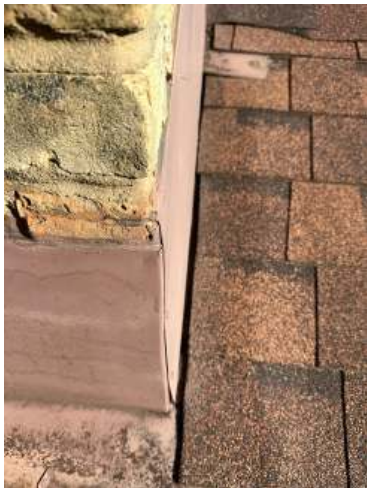
Caulking upgrade on the flashing around the fireplace chimney.  
Roof

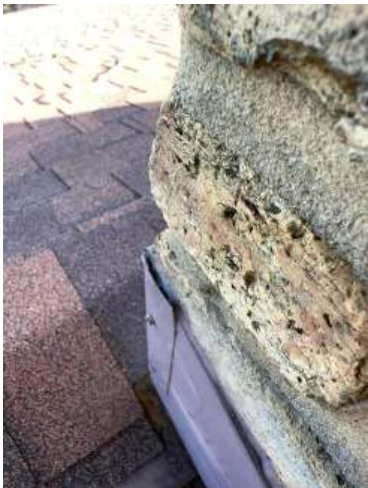
Caulking upgrade on the flashing around the fireplace chimney.  
Roof

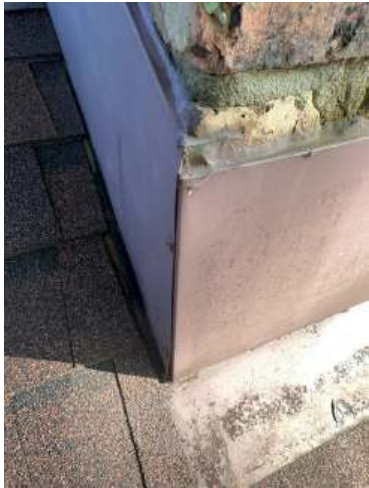
Caulking upgrade on the flashing around the fireplace chimney.

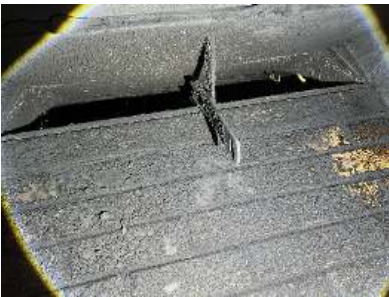
The fireplace housed vented gas logs, and a damper clamp was not present to keep the damper in the open position. This can allow the damper to be closed during operation of the logs, which can allow for CO gas to accumulate to dangerous levels. The installation of a damper clamp is recommended to be conducted by a chimney sweep or other qualified person.

*Because of the gas lighting feature of this fireplace. It is recommended that a clamp be installed so the the flue cannot be fully closed allowing a continual draft of air up the chimney taking the carbon monoxide, if present, out of the home.*  
Living Room

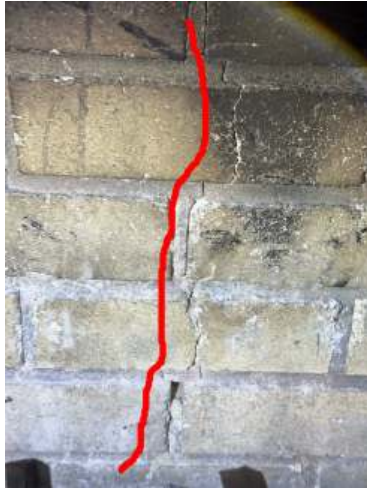
*Crack in the fire brick and grout. This is an internal system and can be replaced by a fireplace contractor.*

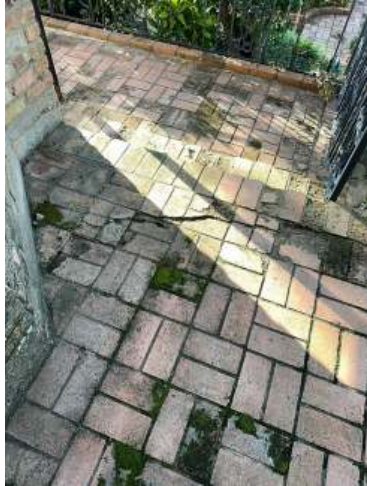
Settling crack in patio.

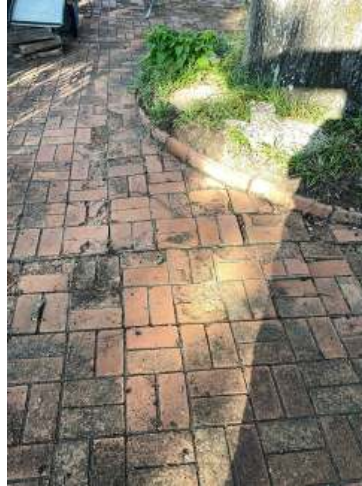
Tree roots lifting the brick pavers on the backyard side of the tree.

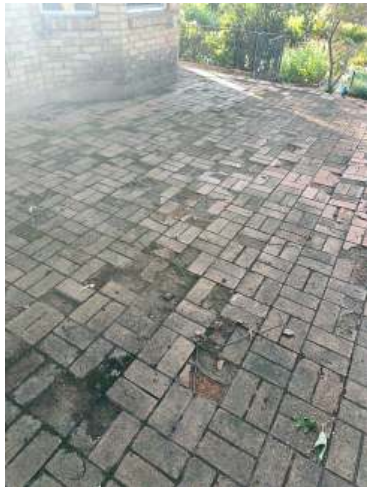
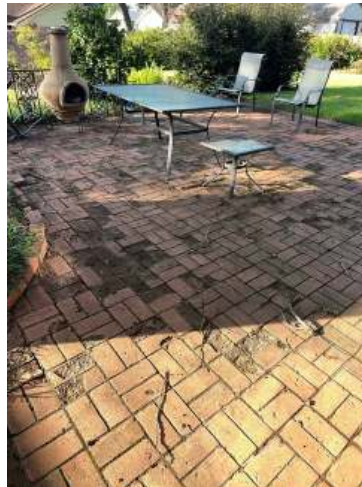
Heavy spalling of the brick was present on portions of the retaining wall. This is most likely due to moisture / water infiltrating the masonry, and as this moisture freezes in winter months damage to the brick occurs. Repairs are recommended to be performed as needed by a qualified mason.

Patio bricks are spalling all over rear patio.

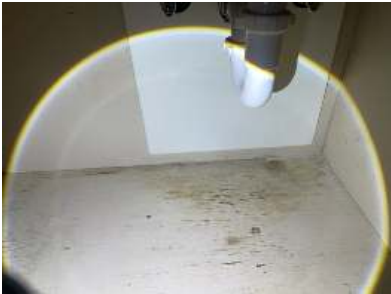
Fungal growth was observed at the back of the sink cabinet. We recommend having a qualified professional evaluate and address this issue.  
Bathroom, Hallway

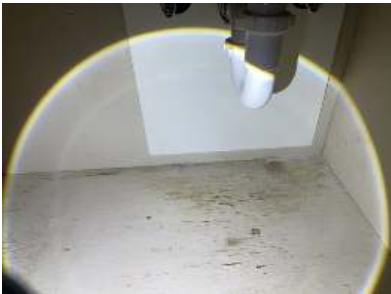
Moisture stains/damage was noted in one or more of the cabinets.

Biological fungal growth in base of cabinet.  
Hallway Bathroom

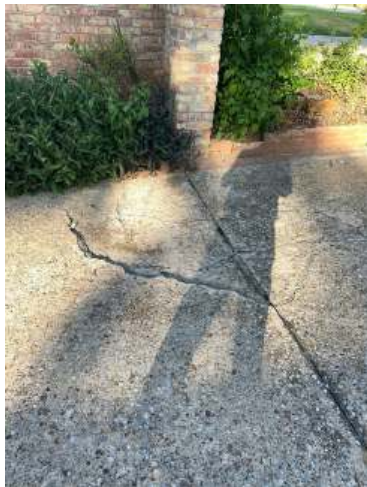
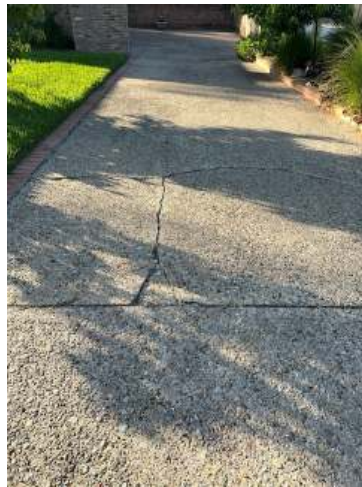
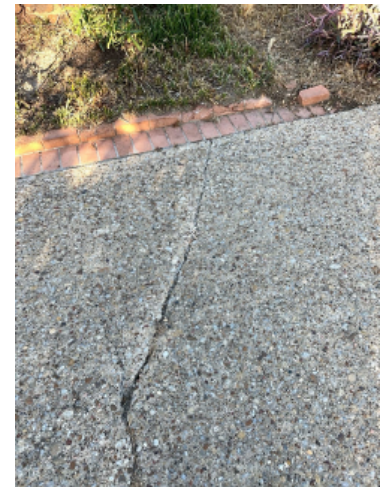
There were areas of damaged concrete present at the referenced area(s). An evaluation and repairs as needed is recommended to be performed by a concrete contractor.

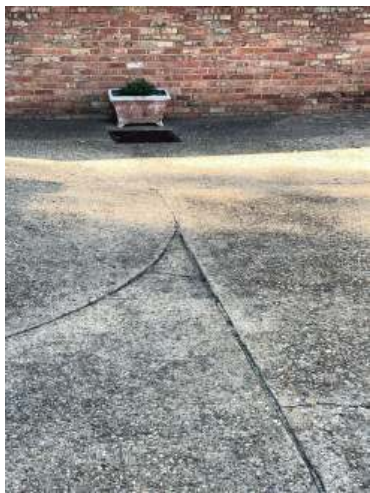
**FYI** - The driveway pitched towards the structure. Driveways / hardscapes should pitch away from the structure at 1/4 inch per foot (2% grade) for a span of 10 feet, to allow for the runoff of rainwater. This may not always be possible due to the layout of the lot, and in these instances drain(s) are typically used to manage rainwater. A drain/drains were

present here and determining their performance lies beyond the scope of a home inspection and is excluded from this inspection. I recommend consulting with the seller(s) as to the performance of the drain(s) and any past water infiltration into the structure due to the negative pitch of the driveway.

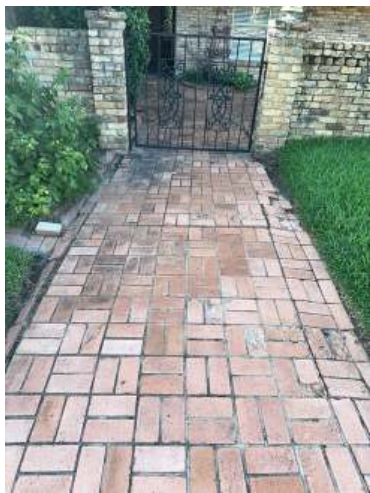
Brick pavers are spalling and settling down the entire path. Rebuilding the walkway base is recommended.  
Front Entrway

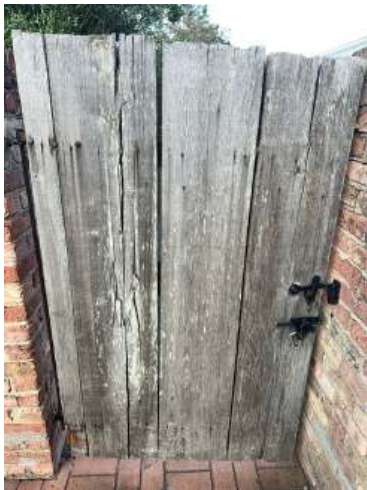
Wooden gate doors are deteriorating, recommend replacing the boards.  
Left, Entry, Side Yard

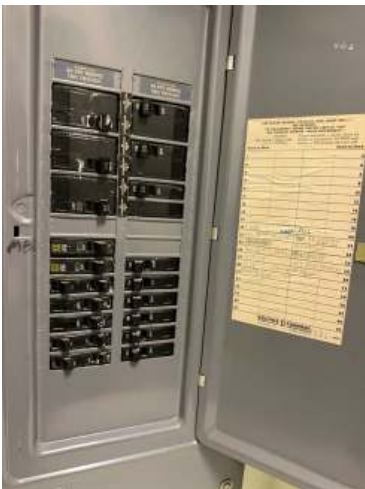
We observed missing label information on the circuit directory of the main service panel. We recommend having all breakers clearly and accurately labeled to ensure safety and ease of identification.  
Bedroom 2, Bedroom Closet

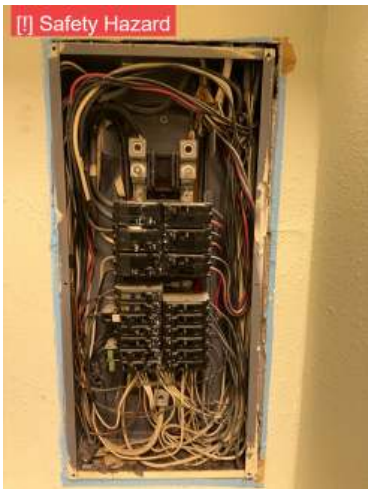
Neutral wires were found to be double tapped, means two neutral wires connected under one screw, which the manufacture recommends not to do. Recommend an electrician to evaluate and repair.

Grounded "neutral" conductors were sharing a terminal with another neutral and/or ground wire(s) (EGC's) on the terminal bar(s). When a neutral conductor is sharing a terminal with another neutral conductor, it can prevent a circuit from safely being isolated for repair. It can also create an overvoltage condition that may damage lighting and appliances during servicing of the panel and circuits.

All grounded neutral conductors in this panel are recommended to be isolated on a separate terminal on the terminal bar by a licensed electrician.

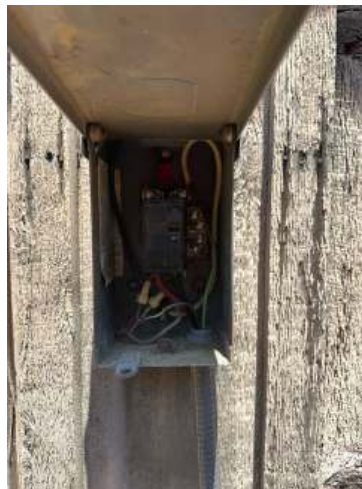
The exterior HVAC unit was protected by a breaker larger than the maximum designated sized breaker as found on the exterior unit's data tag. The installation of the proper sized breaker as needed is recommended to be conducted by a licensed electrician.

During the inspection, we observed that this 50-amp breaker at the exterior HVAC unit is oversized. It exceeds the maximum designated breaker size specified on the Left, Side Yard

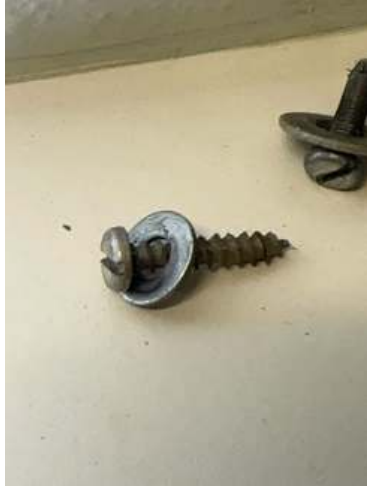
There were sharp-pointed or self tapping metal screws securing the electrical panel cover in place. These are prohibited as they may puncture wire insulation and electrify the panel box, becoming an electrocution hazard. These screws should be replaced with approved, flat-tipped screws by a licensed electrician with a review of the panel conducted at that time to ensure no wiring has been damaged.

*Improper screw in the dead front of the main electrical panel. This sharp point could puncture the wire and cause a short or worse a fire. Recommend replacing this screw with a blunt tip screw.*

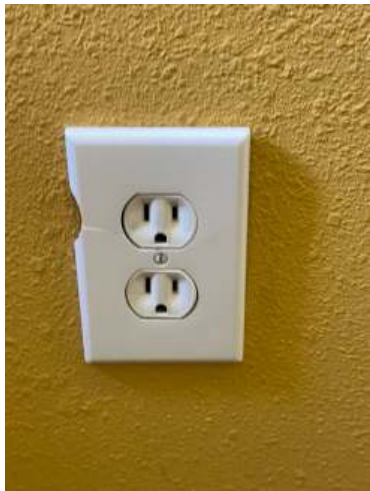
The cover plate(s) were damaged on receptacle(s) in the referenced area(s). This is a potential safety hazard as the damage could allow for displacement of the plate, exposing live wiring. The installation of new plate(s) by a qualified person is recommended to be conducted on any plates that are damaged throughout the home.

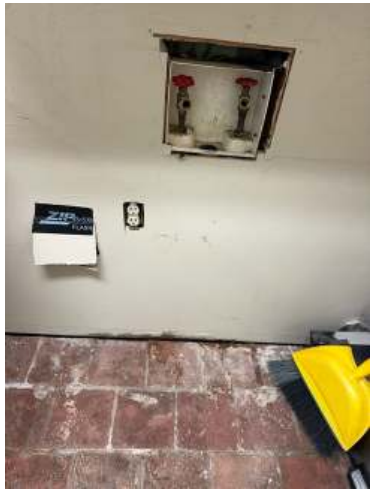
Laundry Room

There were receptacles with missing cover plate(s) at the referenced area(s). This is a safety hazard, as someone could be shocked by touching live wires. The installation of new plates is recommended on any and all plates that are missing throughout the home.

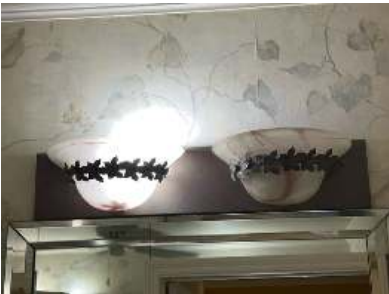
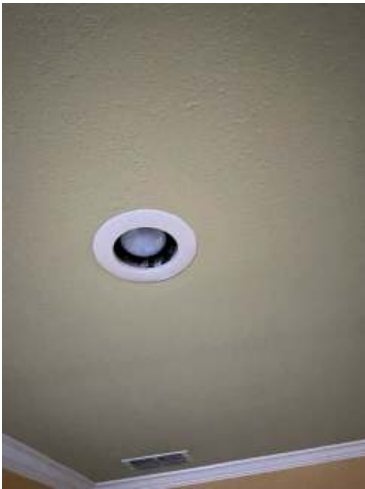
When the referenced light was powered on, the bulb(s) immediately burned out. An evaluation of this light and switch is recommended to be conducted by a licensed electrician to confirm a wiring fault or other deficiency did not allow for this.

Possible bulb burnt out, recommend replacing.  
Primary Bedroom

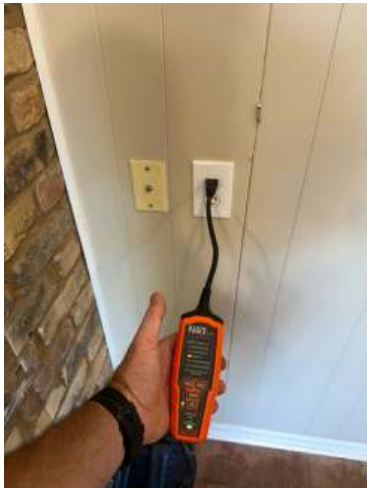
No power to the outlet, recommend electrician to evaluate and repair.  
Living Room

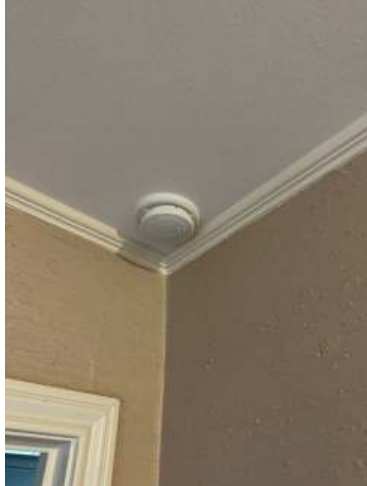
*This is the only smoke detector present for the bedrooms, and it was found to be non-functional during the inspection. We recommend having a qualified technician*

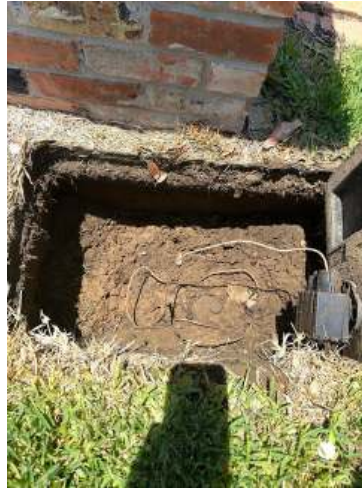
Water meter covered in dirt, this could cause premature failure. Recommend removing the accumulated dirt.

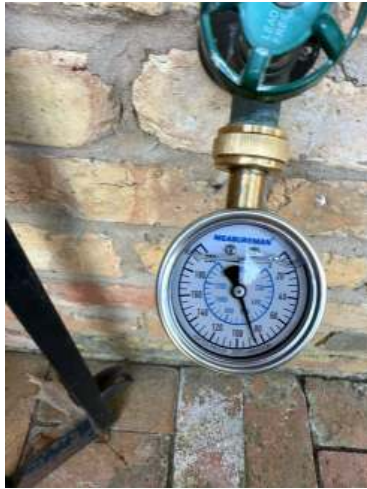
The water pressure at the home was over 80psi at the time of inspection and no (PRV) Pressure Relief Valve was located. The normal water pressure range is 40-80psi to protect water distribution pipes from leaking due to excessive pressure. Repairs to achieve acceptable pressure are recommended.

Water pressure over 80 psi. Recommend evaluation by plumber to determine if a PRV is present to lower the water pressure or install a pressure tank on the hot water heater.

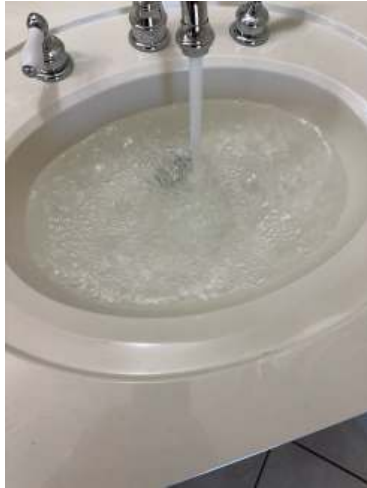
Primary Bathroom

The sink had slow or hindered drainage. Repairs are recommended to be performed as needed by a licensed plumber or other qualified person to achieve proper drainage.

*Primary bathroom sink not draining very quickly. Drain line under the sink is sloped in the wrong direction slightly. The sink does drain just not as fast.*

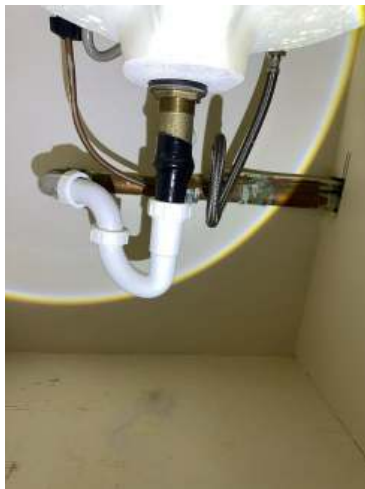
Primary Bathroom

The drain assembly has been puttied or sealed where it is seated to the sink. I recommend consulting with the seller(s) as to why this was done, as this is typically done to address a leak. If they have no information, evaluation is recommended by a licensed plumber.

Tape wrapped around sink drain pipe in master bathroom.

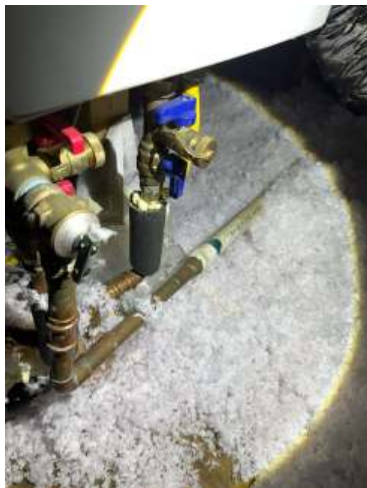
Attic

PVC pipe is not rated for the type of pressure of temperature. Recommend replacing with CPVC 3/4 inch pipe or copper.

PVC was used for the TPR valve discharge tube. TPR valve discharge tubes should be comprised of a material that is approved for distribution pipe use in the home, including copper, aquapex, galvanized steel, or CPVC. Replacement of the discharge tube is recommended to be conducted by a licensed plumber or other qualified person.

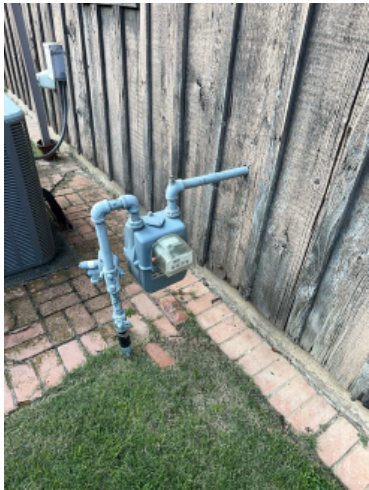
3: Gas Pipe Bonding: Not Visible

Confirmation of gas pipe bonding not visible at time of inspection. Recommend ensuring that the gas pipes are bonded prior to closing.

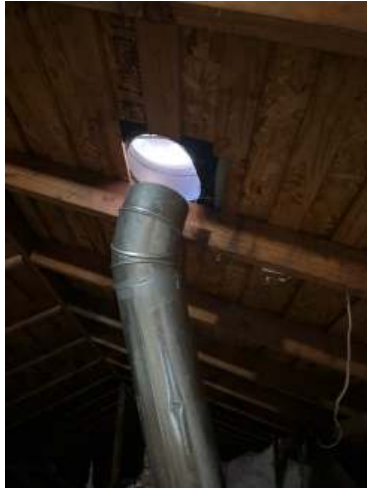
Attic

The kitchen exhaust fan was observed terminating in the attic. Exhaust fans should be vented to the exterior to limit condensation and moisture in the attic. Repairs are recommended to be performed to properly vent the fan to the exterior by a qualified person.

Here in the attic, you can see the kitchen exhaust vent is not properly connected and terminates inside the attic space instead of venting to the exterior. I recommend having a qualified contractor repair this to ensure it vents

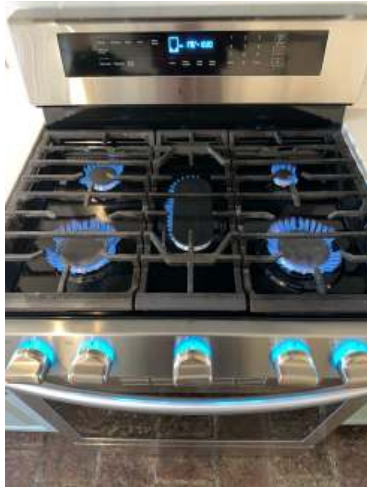
During the inspection of the kitchen range, we observed that the center, front right, and front left burners are not lighting fully or evenly. We recommend  
Kitchen

Gas burner(s) were present that were not producing flame all the way around the burner. Repairs to the burner as needed to achieve proper operation is recommended to be conducted by an appliance repair company.

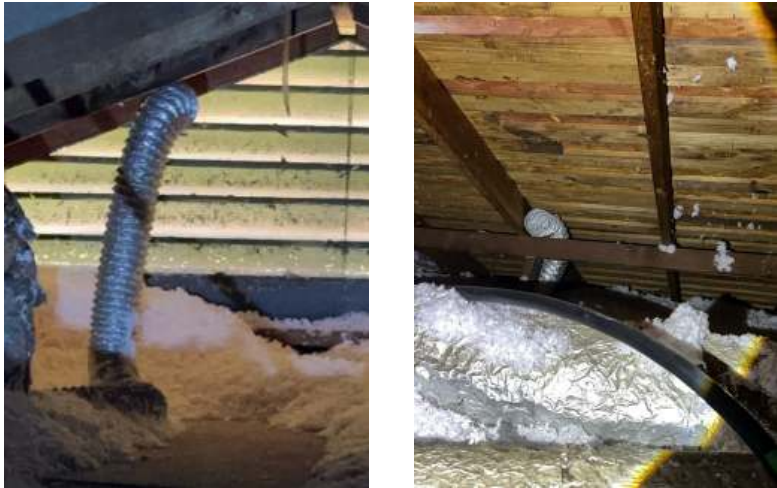
3: Bathroom Fan(s): Terminating in Attic

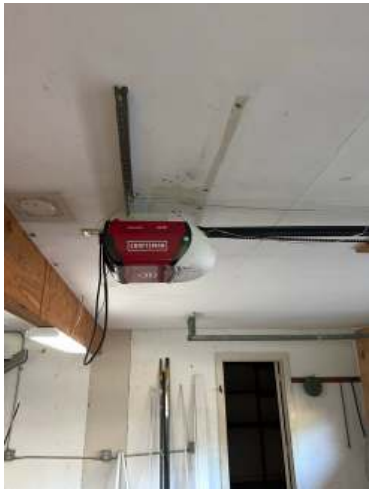
📍 Garage

2: Garage Door Extension Spring(s) - Sprung

During the inspection, the **garage door extension springs** were found to be stretched beyond their normal length, commonly referred to as "sprung." This condition creates a weakened point in the spring, reducing its ability to safely support the door and increasing the likelihood of the door slamming shut unexpectedly.

It is recommended that a qualified garage-door technician re-tighten the affected spring(s) or replace them if re-tensioning is not feasible, to restore proper operation and ensure safety.

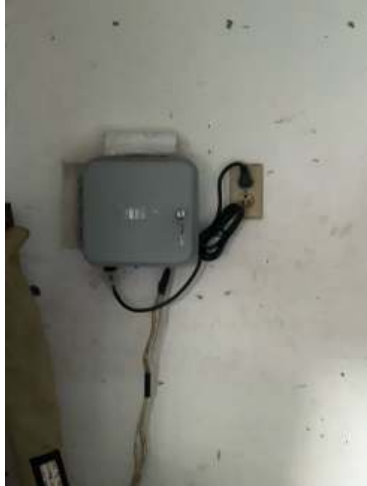
In the inspectors' opinion, the sprinkler system appeared to be in **serviceable condition**.

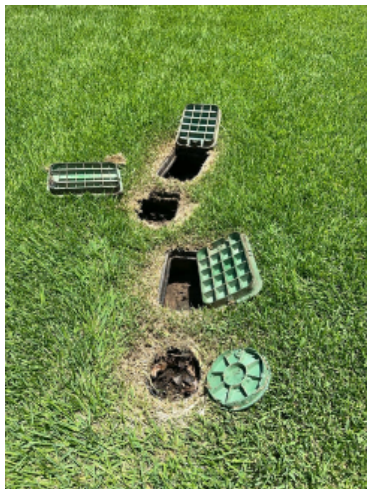
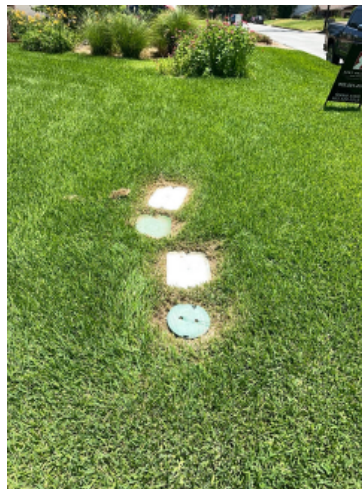
### 3: Valve box location

☒ Front of home
